Aquatic Groundwater Dependent Ecosystem Assessment

Upper Ventura River Groundwater Basin

prepared for
Upper Ventura River Groundwater Agency
202 West El Roblar Drive
Ojai, California 93023

prepared by
Rincon Consultants, Inc.
180 North Ashwood Avenue
Ventura, California 93003

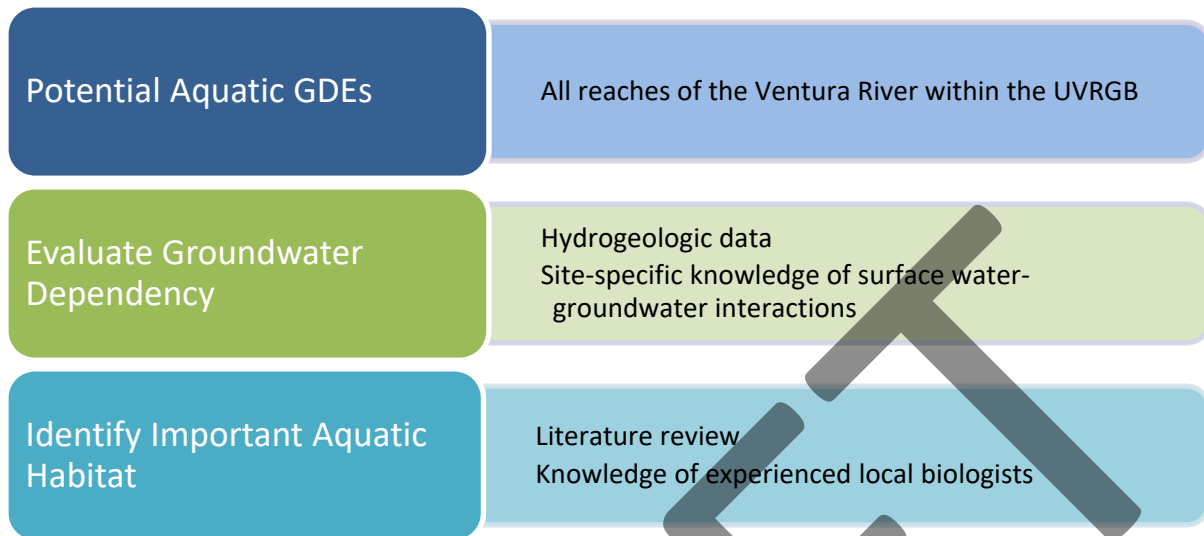
Figure 1 Aquatic GDE Identification Process

As mentioned in the riparian GDE assessment, the Natural Communities Commonly Associated with Groundwater (NCCAG) dataset (DWR 2021) was used to establish potential riparian GDEs within the UVRGB, which were then screened to determine actual riparian GDEs present within the basin (Rincon 2021). To determine aquatic GDEs that exist within the basin, a slightly different approach was necessary. For this analysis, all reaches of the Ventura River within the UVRGB were initially considered as potential aquatic GDEs. Local hydrogeologic data and site-specific knowledge were then used to analyze groundwater-surface water interactions within each reach of the river that falls within the UVRGB. Actual aquatic GDEs were then identified based on a review of published literature on important aquatic habitat and fish passage areas within the UVRGB (e.g., CDFW 2017, ENTRIX 1999), as well as the professional judgment of local biologists with extensive experience working in the Ventura River Watershed. Figure 1 provides an overview of the process used for identifying aquatic GDEs within the UVRGB.

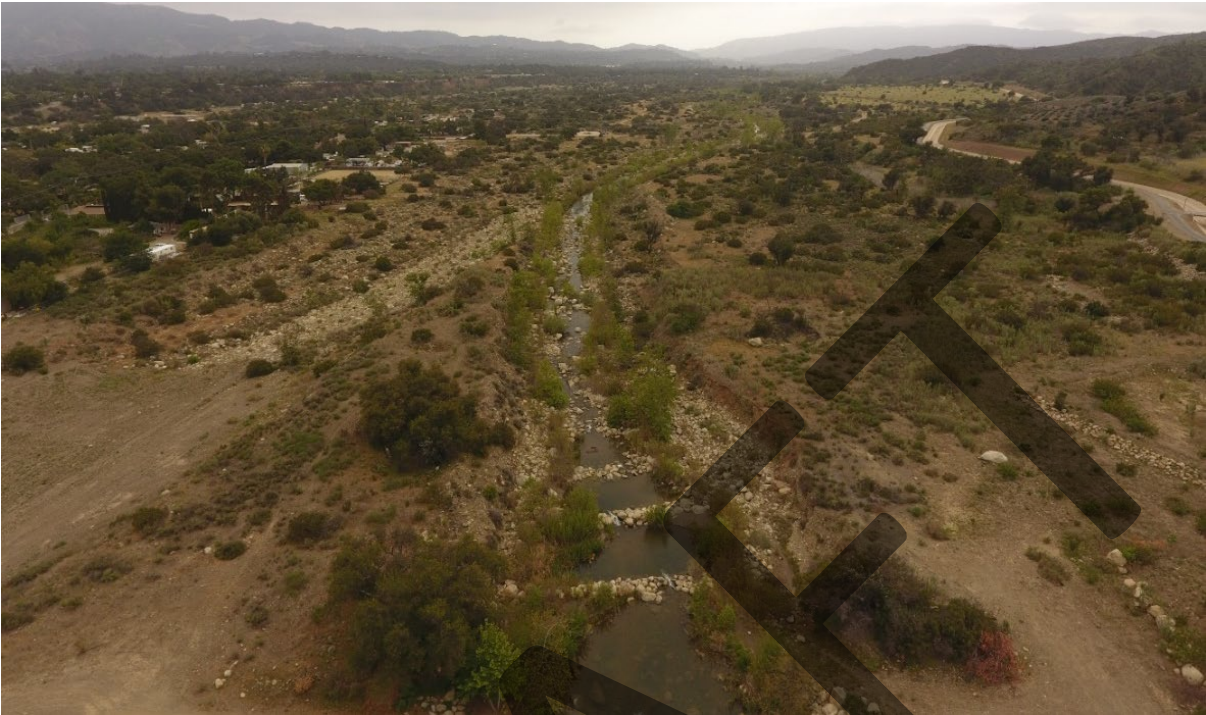
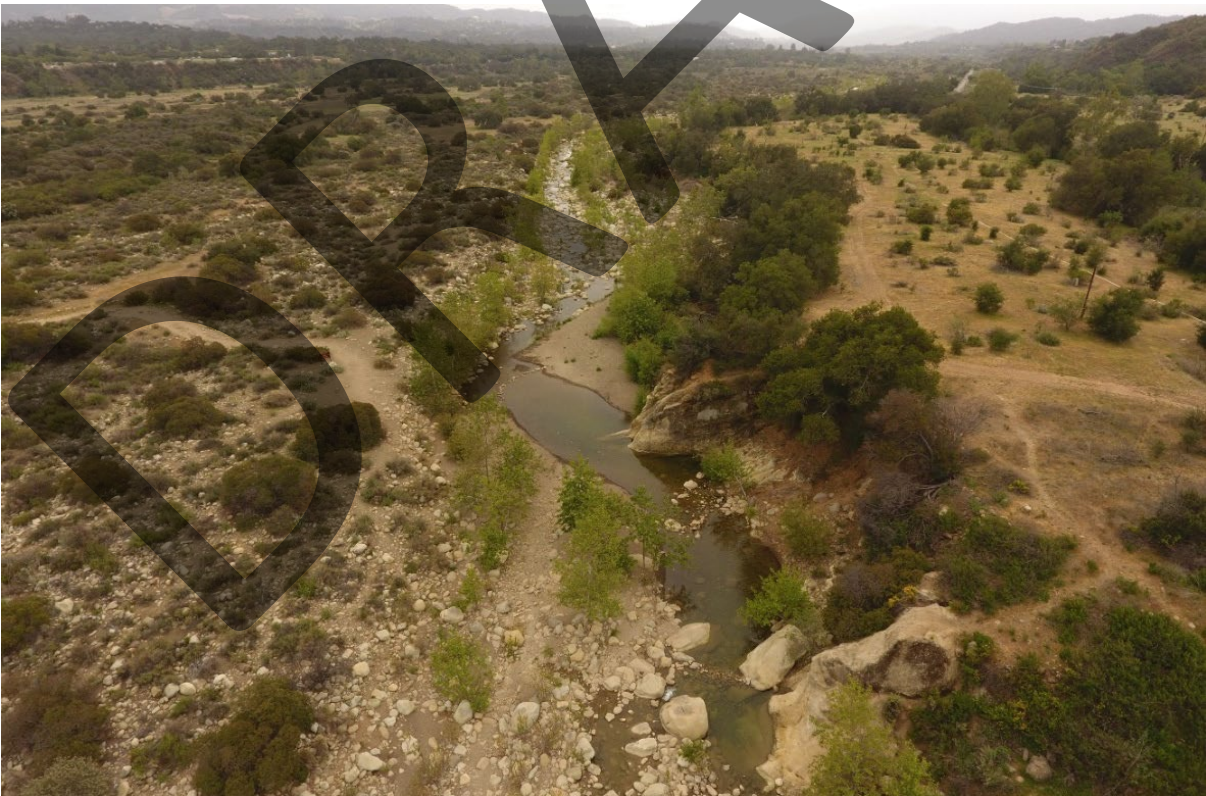
Figure 6 North Robles Habitat Area Photographs

Photograph 1. Northern portion of North Robles Habitat Area (facing south)

Photograph 2. Southern portion of North Robles Habitat Area (facing south)

The North Robles Habitat Area is a dynamic area that includes surface flows from upstream areas that eventually go subsurface as flow enters the wide floodplain in the Ojai Valley Land Conservancy Ventura River Preserve. Steelhead have been documented migrating through this area, although rearing conditions in this reach can be unfavorable due to the high densities of non-native aquatic species (i.e., bullfrogs, bass and other sunfish) and the tendency for the area to go dry for several months each year. A few deep pools are located within the area that can provide important rearing habitats for special status aquatic species. However, these pools are known to naturally deplete in most dry seasons. Figure 6 presents photographs taken via aerial drone of the northern and southern portions of this area.

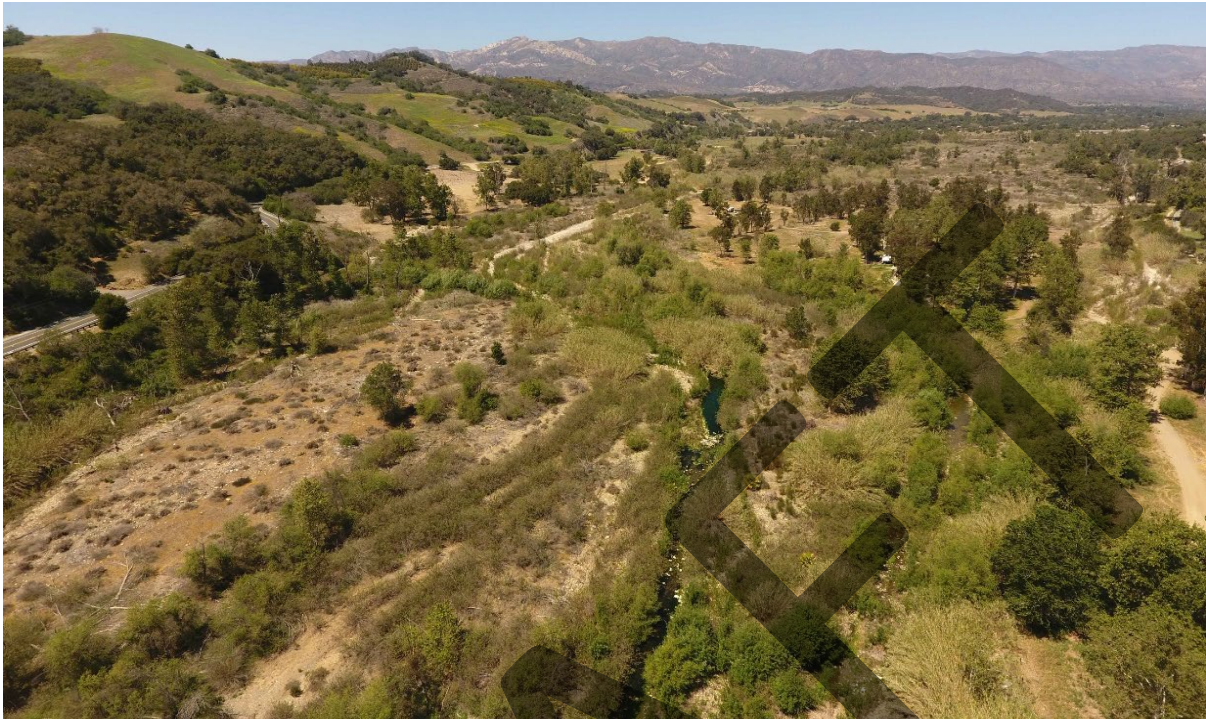
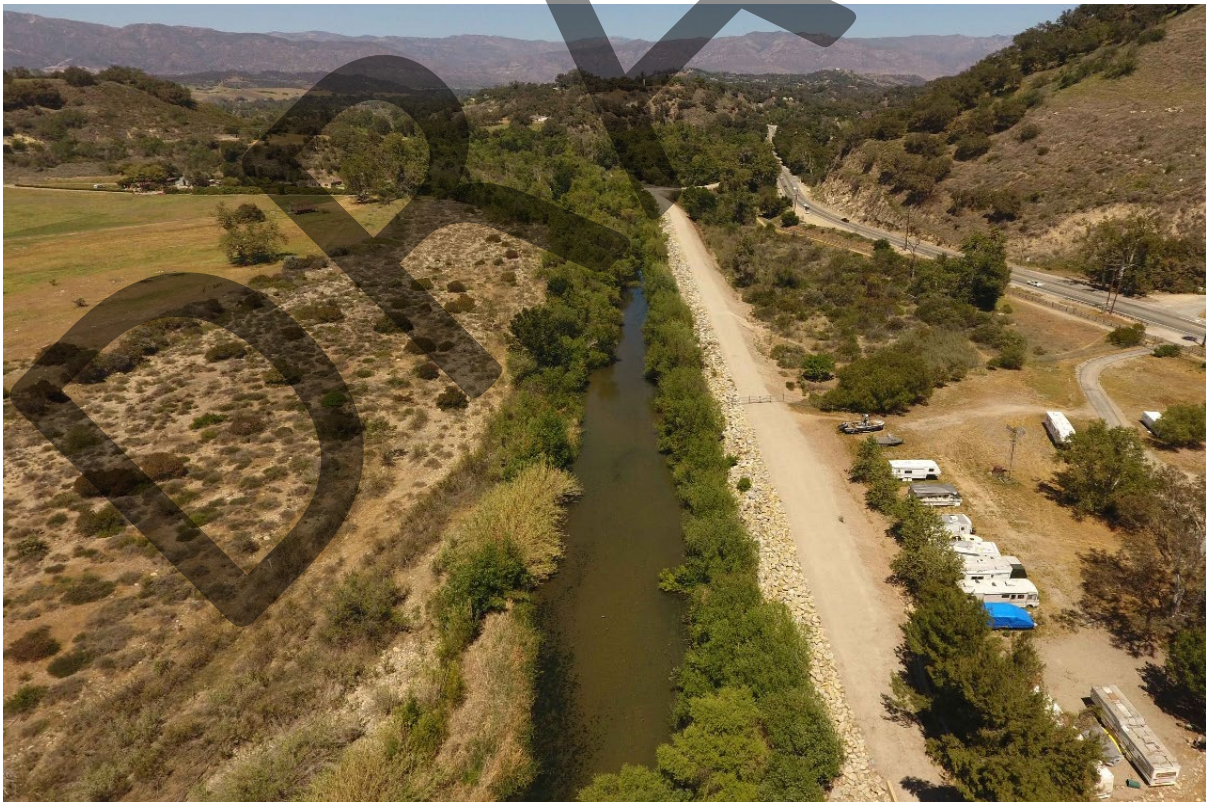
Figure 7 Confluence Habitat Area Photographs

Photograph 1. Northern portion of Confluence Habitat Area (facing north)

Photograph 2. Southern portion of Confluence Habitat Area (facing north)

San Antonio Creek provides important spawning and rearing habitat for steelhead (Payne 2009, Normandeau 2011) and fish must pass through the confluence area to reach this tributary of the Ventura River. One notable pool within the confluence area contains water even during periods of drought when many other portions of the river go dry² (CDFW 2017). Figure 7 presents photographs taken via aerial drone of the northern and southern portions of this area.

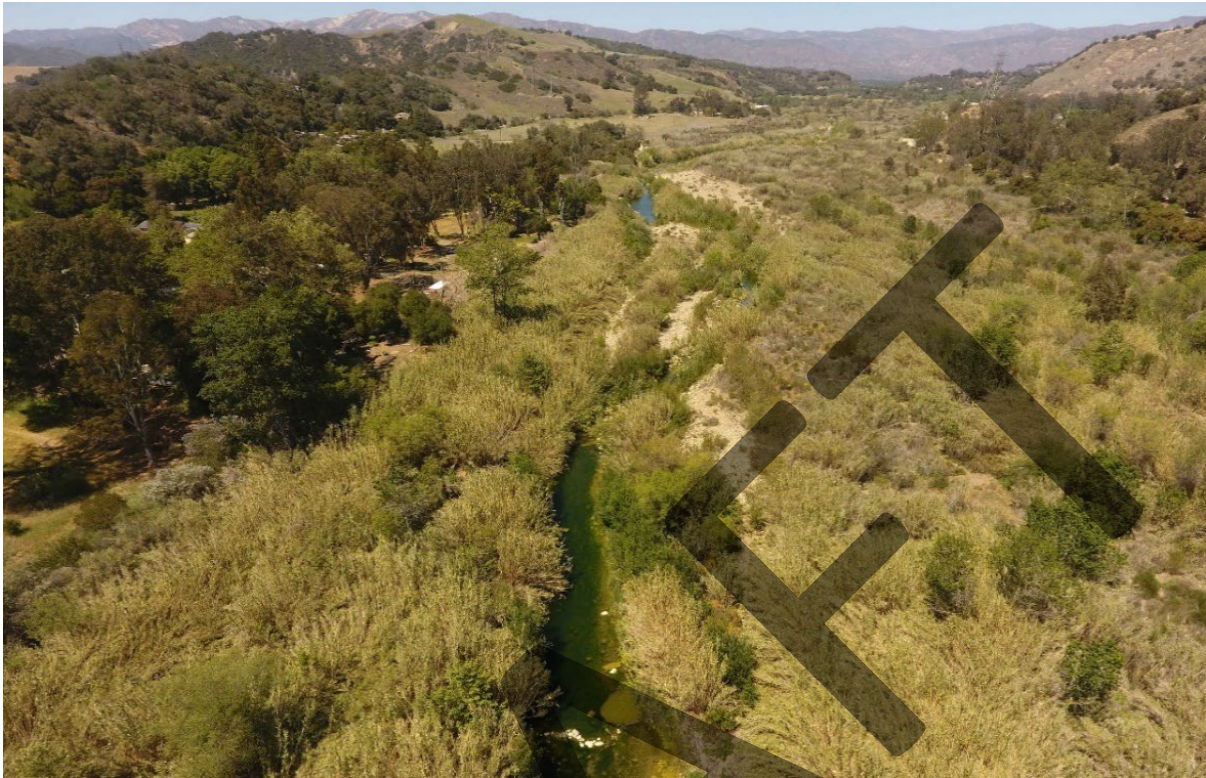
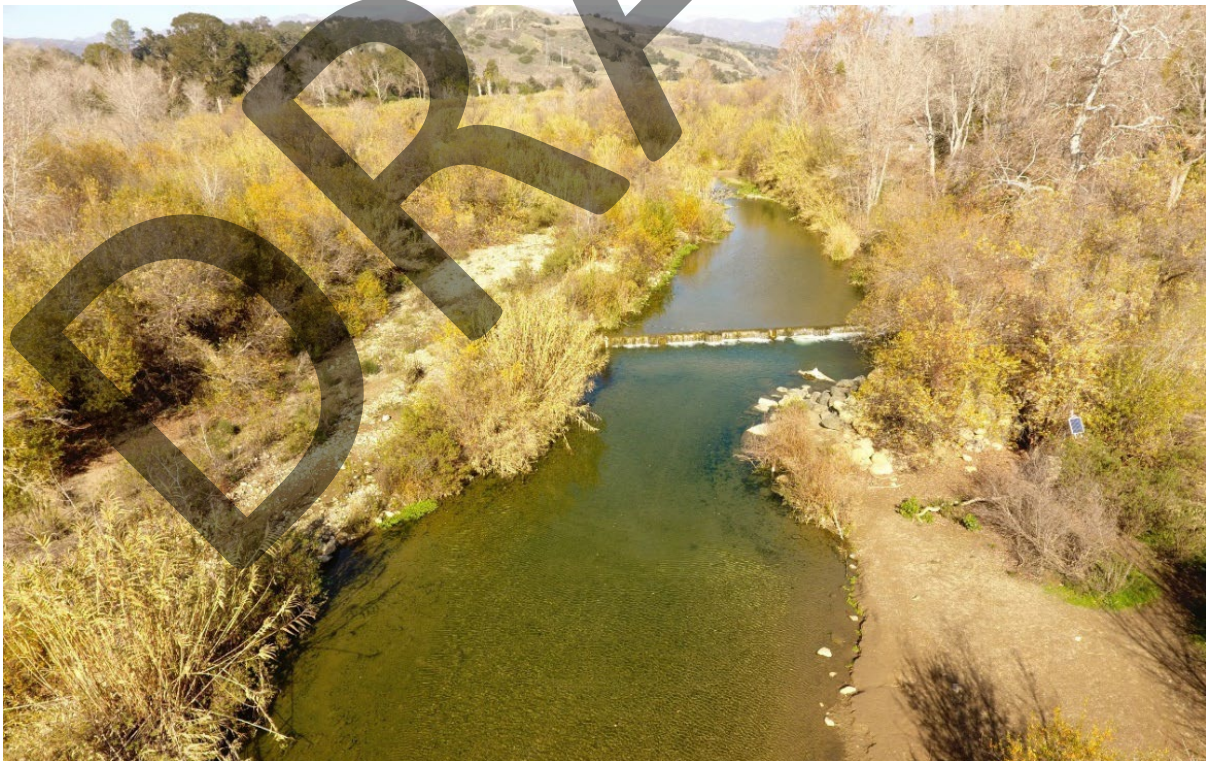
Figure 8 Foster Park Habitat Area Photographs

Photograph 1. Northern portion of Foster Park Habitat Area (facing north)

Photograph 2. Southern portion of Foster Park Habitat Area (facing north)

The Foster Park Habitat Area of the Ventura River occurs in the southernmost portion of the UVRGB. The Ventura River at Foster Park is considered perennial but certain reaches of this area apparently went dry at some point over an unknown duration during the current drought (M. Garcia, personal communication, 2019). Figure 8 presents photographs taken via aerial drone of the northern and southern portions of this area.

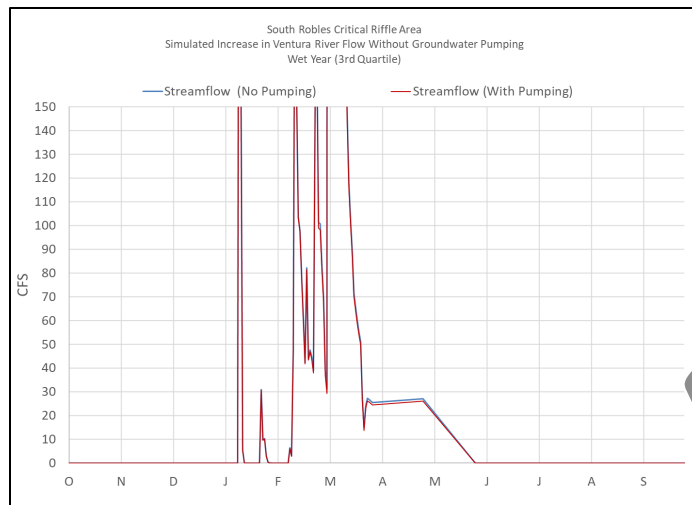
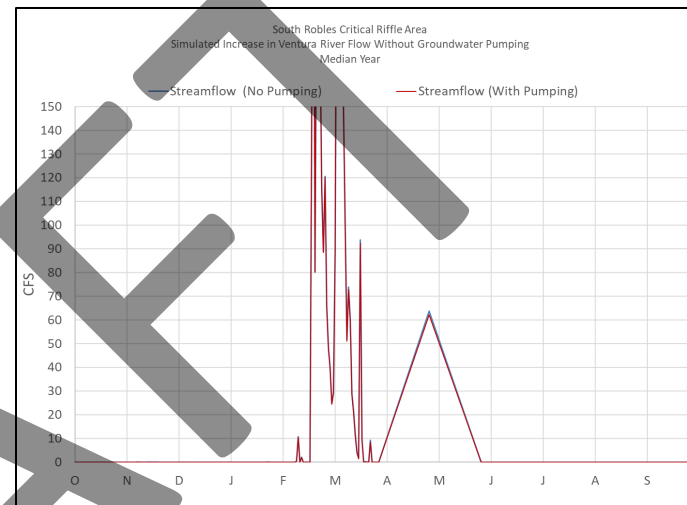
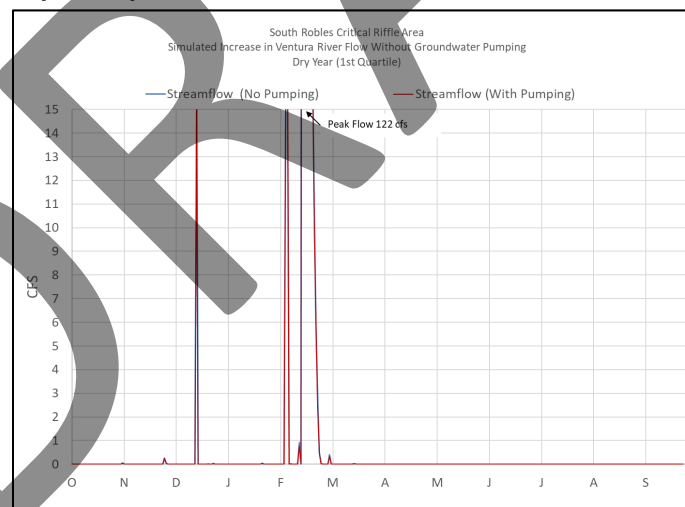
Figure 9 Simulated Streamflow at South Robles Critical Riffle
Wet Example Year

Note: Model presents data on a daily basis for November through March, and monthly for April through October

Figure 9 and Figure 10 present the simulated streamflow with and without pumping at the South Robles and South Santa Ana Critical Riffles for the wet, median, and dry example water years. As illustrated in these hydrographs, streamflow depletion (the difference between pumping and no pumping) is nearly indistinguishable and the blue lines and red lines are close together. Considering that fish pass these critical riffles during storm pulses and when flows recede following storm pulses, it appears from the modeling results that there is likely minimal or no effect on interconnected surface water in these aquatic GDEs.

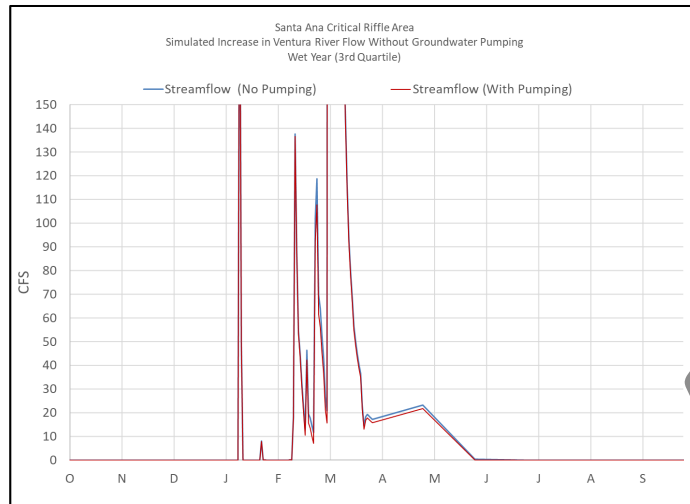
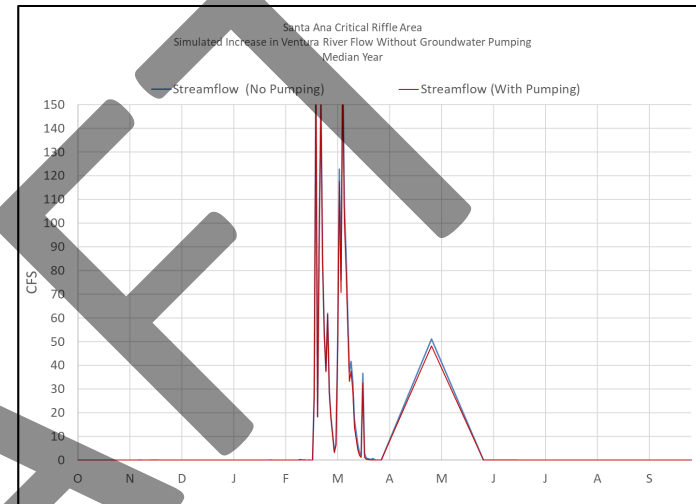
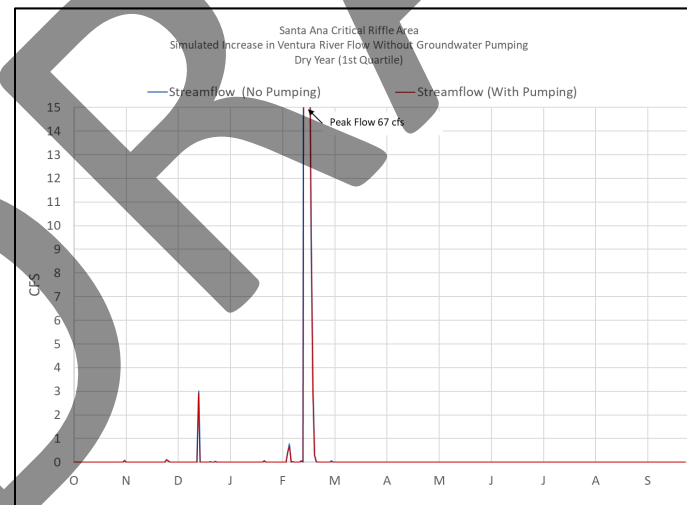
Figure 10 Simulated Streamflow at South Santa Ana Critical Riffle
Wet Example Year

Note: Model presents data on a daily basis for November through March, and monthly for April through October

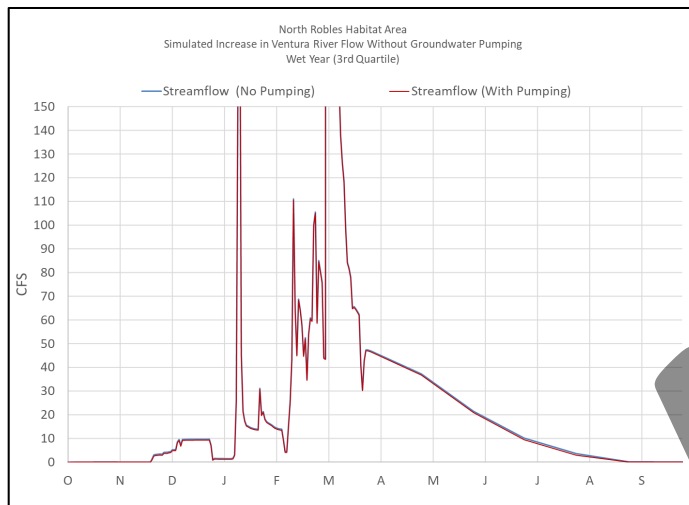
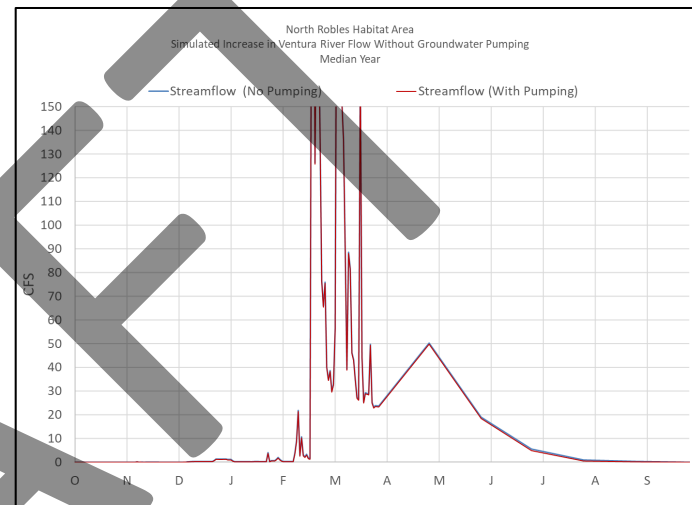
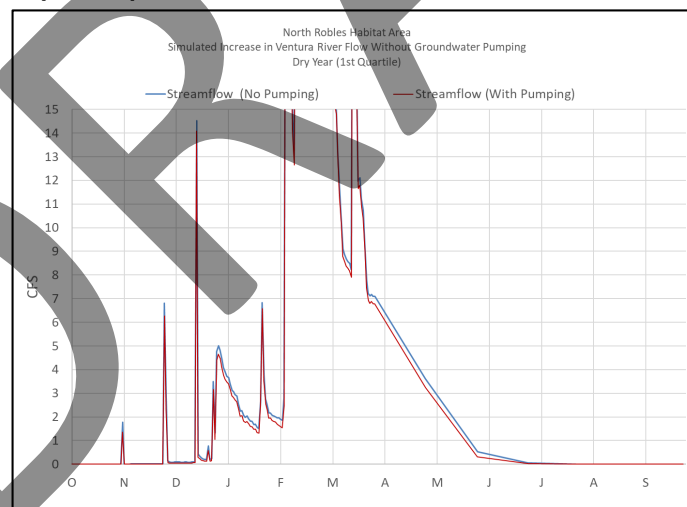
Figure 11 Simulated Streamflow at North Robles Habitat Area
Wet Example Year

Note: Model presents data on a daily basis for November through March, and monthly for April through October

Figure 11 presents the simulated streamflow with and without pumping at the North Robles Habitat Area. As illustrated in these hydrographs, streamflow depletion is nearly indistinguishable during each example water year (blue lines and red lines remain close together). The dry example year chart shows visible difference between streamflow with and without pumping, although the difference is approximately 0.2 cubic feet per second (cfs). While the simulated streamflow with

pumping shows this slight depletion, it is important that this is observed during periods of natural streamflow recession. As streamflow without pumping is naturally depleting for these simulated example years, it appears that there is minimal or potentially no effect on interconnected surface water in these aquatic GDEs.

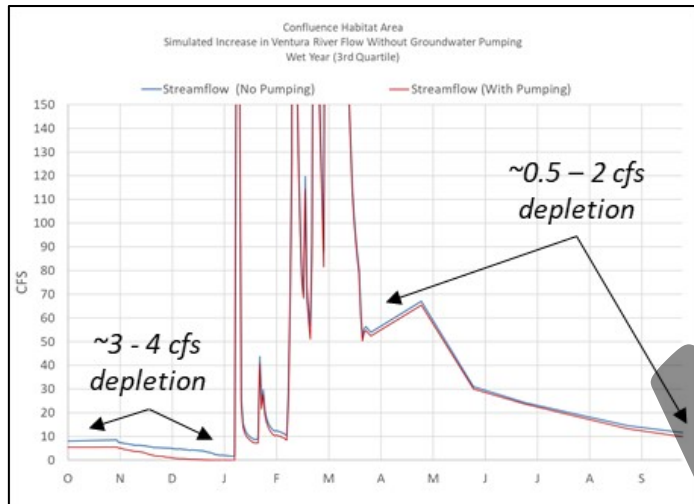
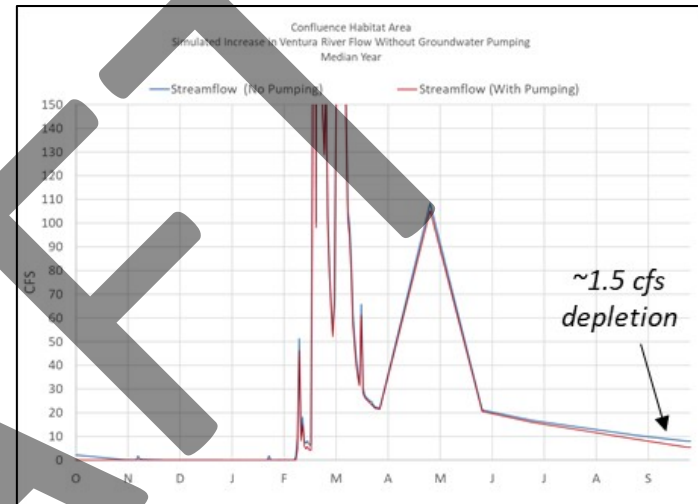
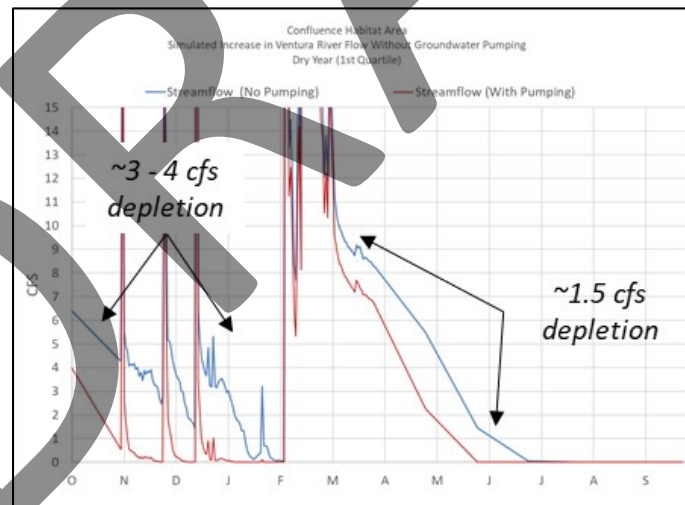
Figure 12 Simulated Streamflow at Confluence Habitat Area
Wet Example Year

Note: Model presents data on a daily basis for November through March, and monthly for April through October

Figure 12 presents the simulated streamflow with and without pumping at the Confluence Habitat Area. As illustrated in these hydrographs, depletions of up to 4 cfs occur during the dry period of both the example wet and dry years. Note that the water year preceding the example median year appears to have been a dry year, and streamflow between October through February was at or near 0 cfs. It also appears that pumping could be accelerating the onset of dry conditions during dry years.

Based on these results, effects from pumping are potentially significant during dry periods. However, limited information related to the conditions of these aquatic GDEs during periods with depleted surface water is available. Aquatic species that live in intermittent or ephemeral environments have adapted to these conditions to survive. Aquatic species could disperse to perennial portions of this habitat area as flows recede or potentially become stranded in isolated habitat areas or killed from exposure as conditions deteriorate. The actual effects at the Confluence Habitat Area related to natural depletion without pumping is currently not known. As such, the specific effects to this area is a data gap and it is unknown what type of impact (significant or not), if any, is occurring.

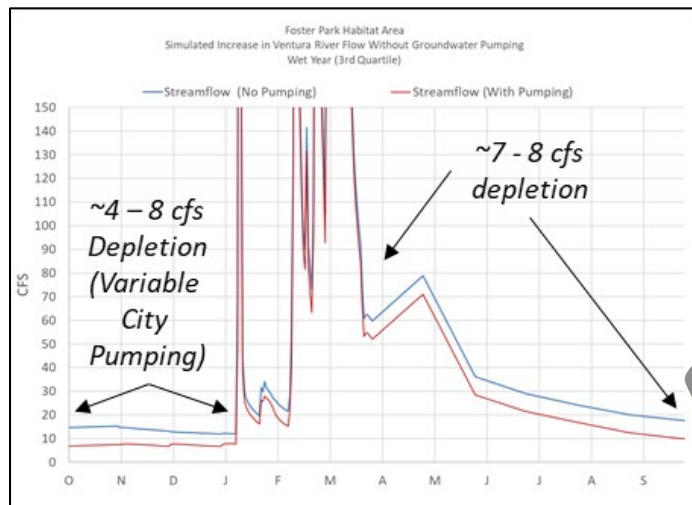
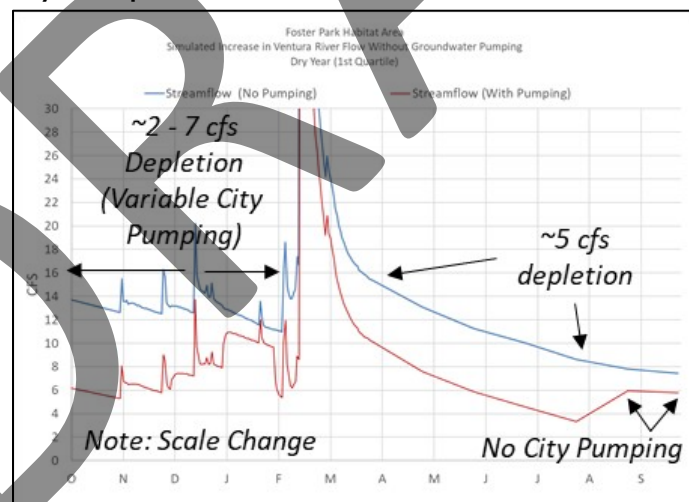
Figure 13 Simulated Streamflow at Foster Park Habitat Area

Note: Model presents data on a daily basis for November through March, and monthly for April through October

Figure 13 presents the simulated streamflow with and without pumping at the Foster Park Habitat Area. As illustrated in these hydrographs, depletions of up to approximately 8 cfs can occur during the dry period of both the example wet and median years (natural streamflow without pumping ranging from approximately 12 to 28 cfs), and up to 7 cfs during the example dry year (natural streamflow without pumping ranging from approximately 10 to 20 cfs). Based on these results and the information discussed below, it appears pumping can cause significant effects to aquatic GDEs during dry periods. However, the City of Ventura (City) has developed pumping thresholds based on studies described below to potentially avoid significant impacts to aquatic GDEs at Foster Park.

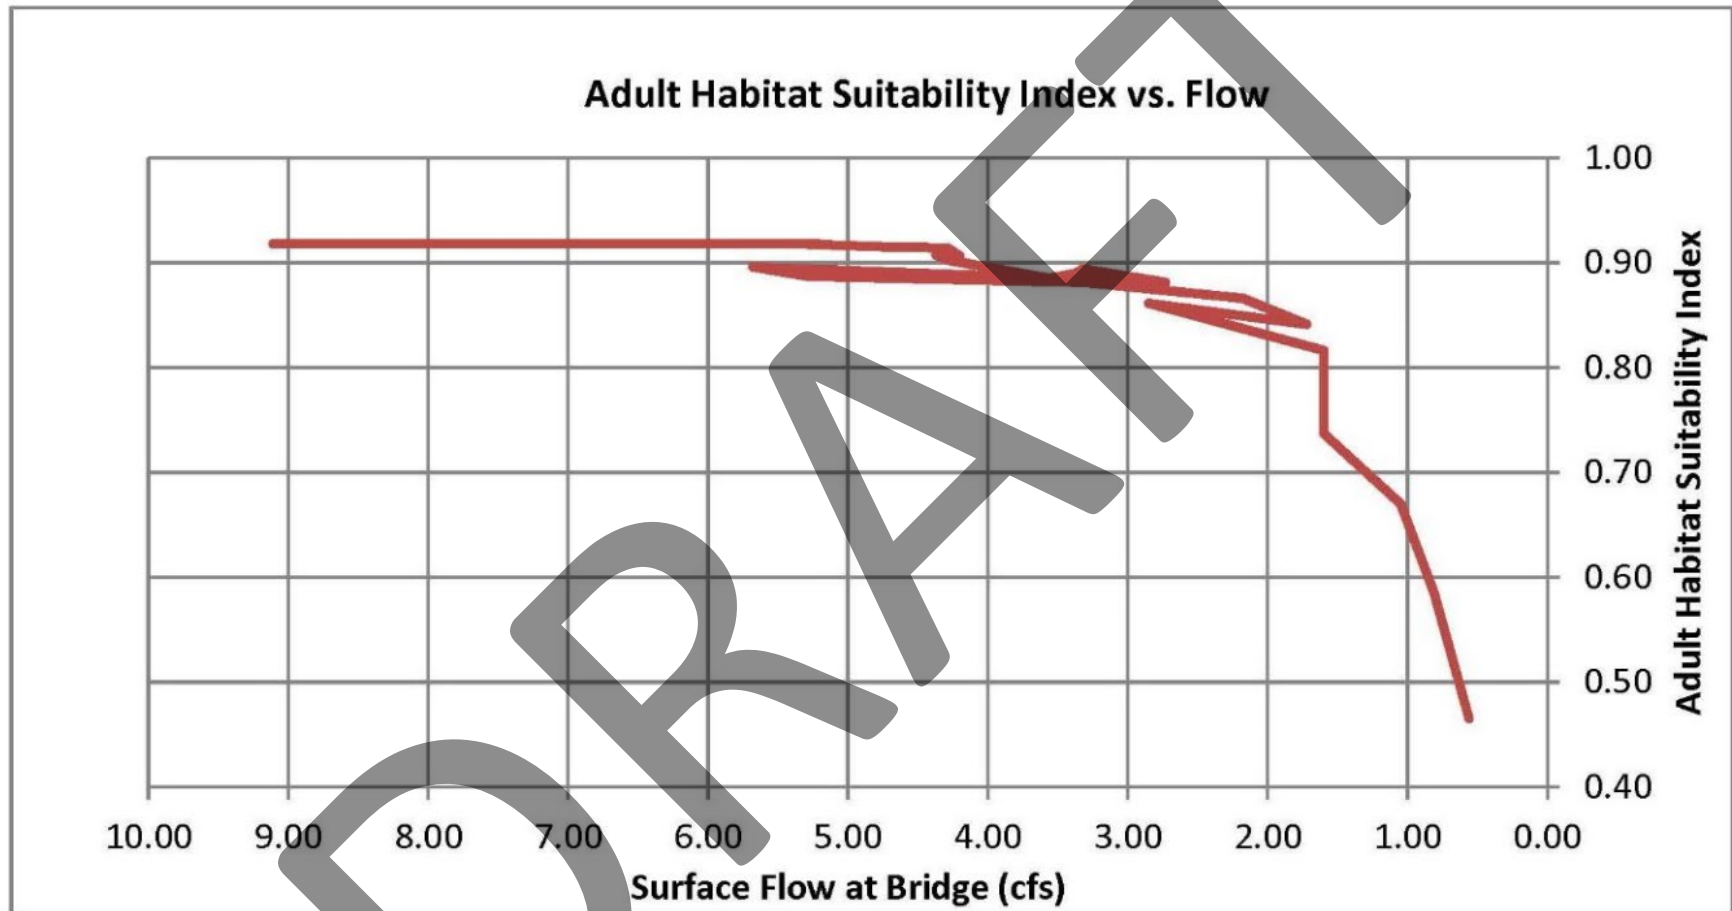
Figure 14 Adult Steelhead Thalweg Depth HSI Scores Related to Flow

Figure taken from Hopkins 2013

Padre conducted a Rainbow Trout Habitat Suitability Indices (HSI) study in the Foster Park area, while a simultaneous surface flow data collection effort was completed by Hopkins (Hopkins 2013). Prior to this study, Hopkins completed an evaluation of interconnected surface water that demonstrated a close relationship between pumping and surface water depletion (Hopkins 2012). According to the Padre study, the HSI scores for all or the majority of the Rainbow Trout HSI variables declined as flows receded. However, the HSI score associated with average thalweg depth

started to decline at around 4 cfs and then dropped precipitously at approximately 2 cfs (measured at the Casitas Vista Road bridge) (Figure 14). It appears that this was the only variable that had a sharp decline and provided a clear delineation for quantifiable surface flow thresholds.
