Rincon Consultants, Inc.

January 24, 2025
Project No: 20-10008

**Subject: Riparian Groundwater Dependent Ecosystems Monitoring Report for Water Year 2024
Upper Ventura River Groundwater Agency, Ventura County, California**

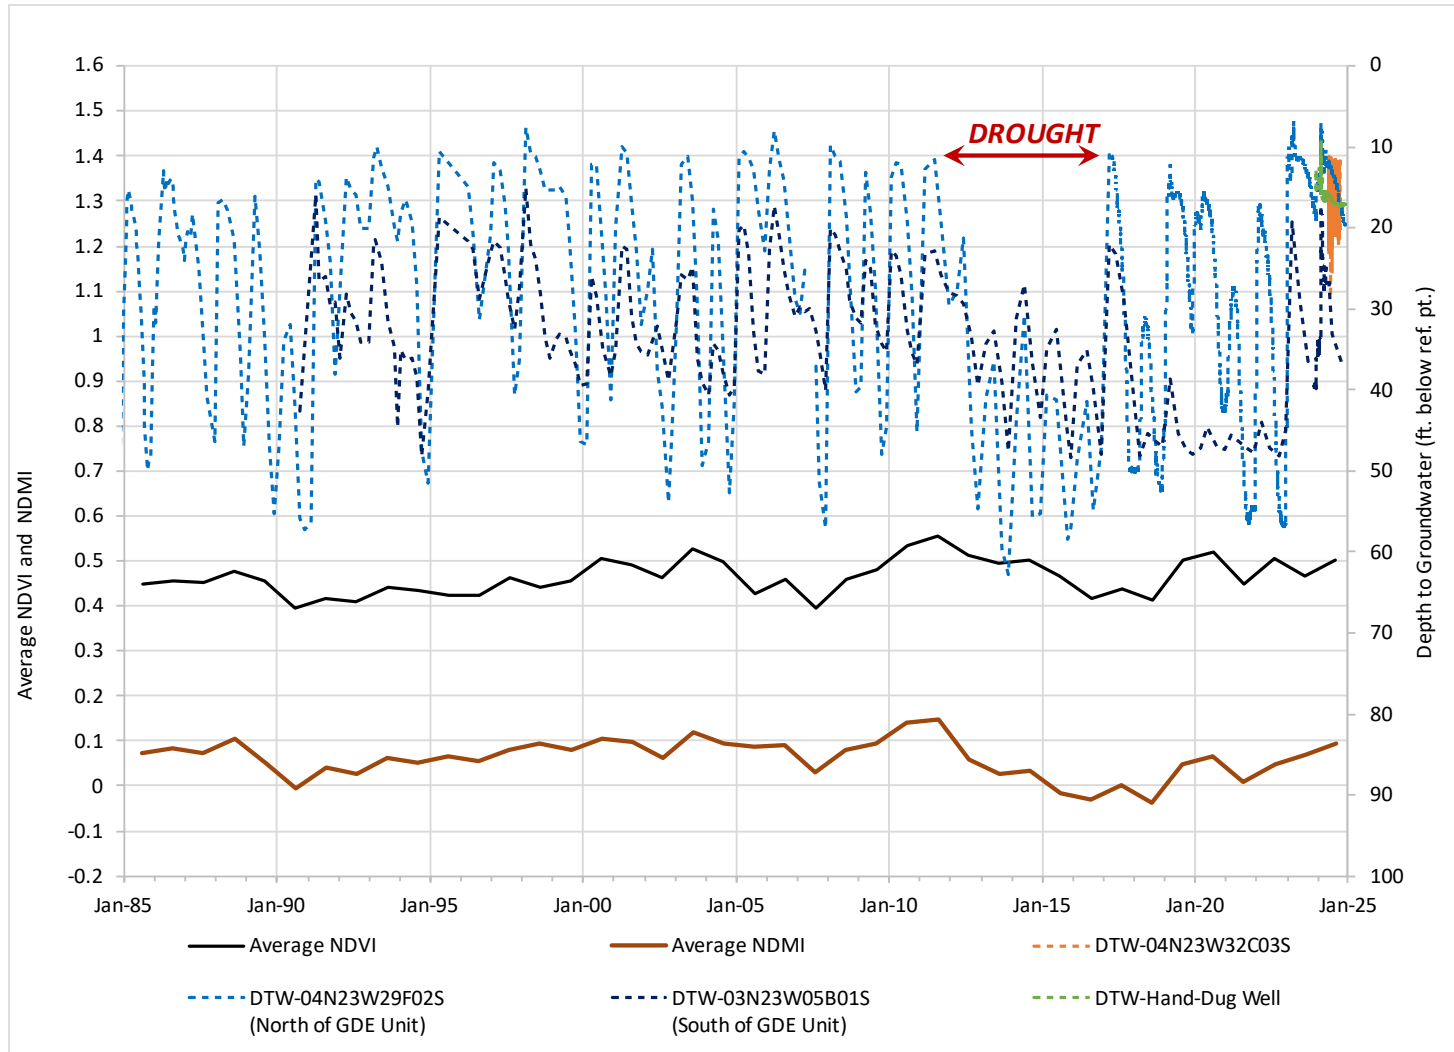
Figure 2 depicts the trends in groundwater level and average NDVI and NDMI values for the South Santa Ana Riparian GDE Unit from 1985 through 2024. Two monitoring wells within the GDE unit, State Well 04N23W32C03S and Hand-Dug Well, were added to the program during Water Year 2024. The water levels at these new monitoring wells will better reflect groundwater conditions within the GDE unit. Water Levels at State Well 04N23W29F02S and State Well 03N23W05B01S, North and South of the GDE unit respectively, are shown to provide a more complete historical record of water level trends. As documented in Rincon's previous annual monitoring report, depth to water (DTW) varies widely at these groundwater monitoring wells (from a high of 6.8 feet in March 2023 to a low of 62.7 feet in December 2013). The overall water level trends show Water Year highs at the beginning of the dry season (typically March through June) and lows at the beginning of the wet season (typically November through January).

Comparing historical groundwater levels to NDVI and NDMI values, we see that these indices fluctuate over time and generally decrease with increasing DTW. During drought conditions between 2012 and 2016, NDVI and NDMI values showed a persistent decline. However, these values also rebounded as DTW decreased again in 2017. A visual analysis of aerial imagery confirmed a decrease in vegetation cover during the severe drought of 2012 through 2016, followed by a resurgence of growth and vegetation cover in subsequent years with more rain.

Figure 2 Groundwater Level Compared to Average NDVI and NDMI for the South Santa Ana Riparian GDE Unit (1985 to 2024)

Following heavy storms during the winter of 2023, groundwater levels at both wells increased while NDVI values decreased. As documented in the previous monitoring report, an analysis of satellite and aerial imagery between Water Year 2022 and 2023 revealed that large areas of riparian vegetation were scoured away by high flow events. During the 2024 Water Year, average NDVI and NDMI values increased in the GDE unit. This increase was likely driven by vegetation establishment and growth following the scouring event in 2023. Figure 4 depicts aerial orthoimagery taken during the 2024 Water Year, which visually shows increased vegetation cover from March 2024 to June 2024.

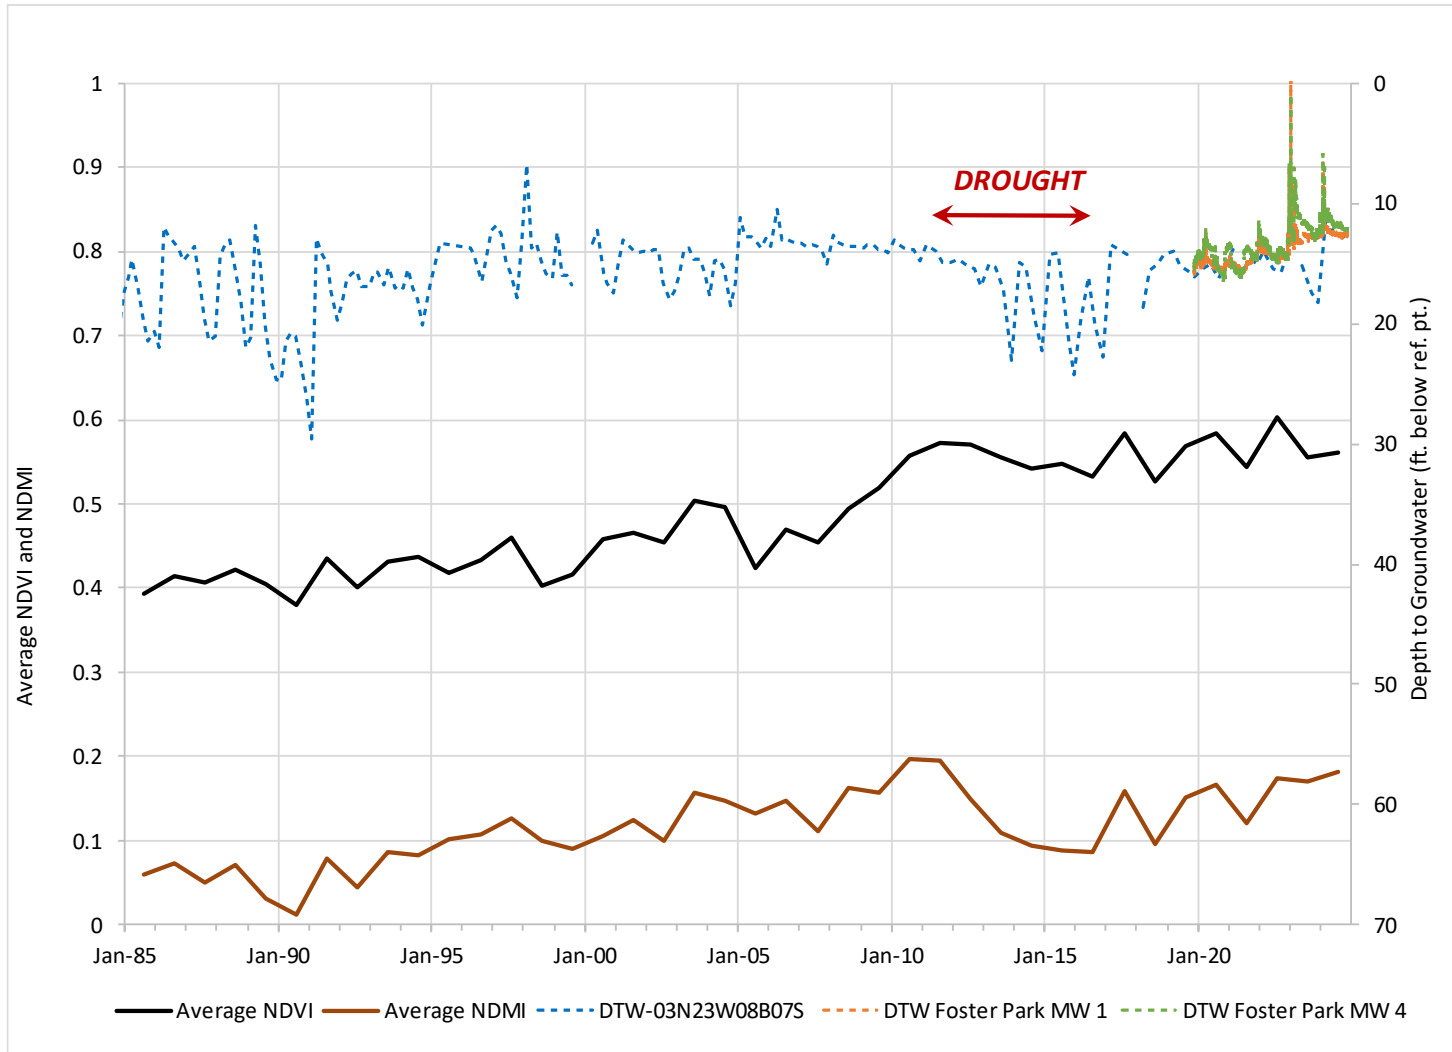
Figure 3 depicts trends in groundwater levels and average NDVI and NDMI values for the Foster Park Riparian GDE Unit from 1985 through 2024. DTW was measured at three wells within the Foster Park Riparian GDE Unit³, varying from a high of 0 feet during a flooding event in January 2024, to a low of 29.6 feet in February 1991.

Similar to the Santa Ana Riparian GDE Unit, NDVI and NDMI values fluctuate over time and generally decrease with increasing DTW. Between 2023 and 2024, NDVI increased, likely due to the revegetation of the scoured channel. More broadly, the general increasing trend of NDVI and NDMI is observed for the Foster Park Riparian GDE Unit from 1985 to 2024, though the potential causes are currently unclear. According to Rincon’s previous assessment, this could be related to influences of past floods or management actions in Foster Park. Aerial imagery confirmed the decrease in NDVI and NDMI values in 2005 and subsequent increase in NDVI and NDMI values from 2006 to 2012 correlated with vegetation scouring and subsequent revegetation following flood events that occurred in 2005. Following a period of increasing index values from 2006 to 2012, NDVI and NDMI values declined during recent drought conditions, but then increased again in 2017 following a water year with moderate precipitation.

Figure 3 Groundwater Level Compared to Average NDVI and NDMI for the Foster Park Riparian GDE Unit (1985 to 2024)

Following heavy storms during the winter of 2023, groundwater levels at all three wells increased while NDVI and NDMI values decreased. As documented in the previous monitoring report, an analysis of satellite and aerial imagery between Water Year 2022 and 2023 revealed that large areas of riparian vegetation were scoured away by high flow events. During the 2024 Water Year, average NDVI and NDMI values increased in the GDE unit. Part of this increase may be due to increased vegetation cover after revegetation of the area following the scouring event in 2023. Figure 5 depicts aerial orthoimagery taken during the 2024 Water Year, which visually shows increased vegetation cover from March 2024 to June 2024.

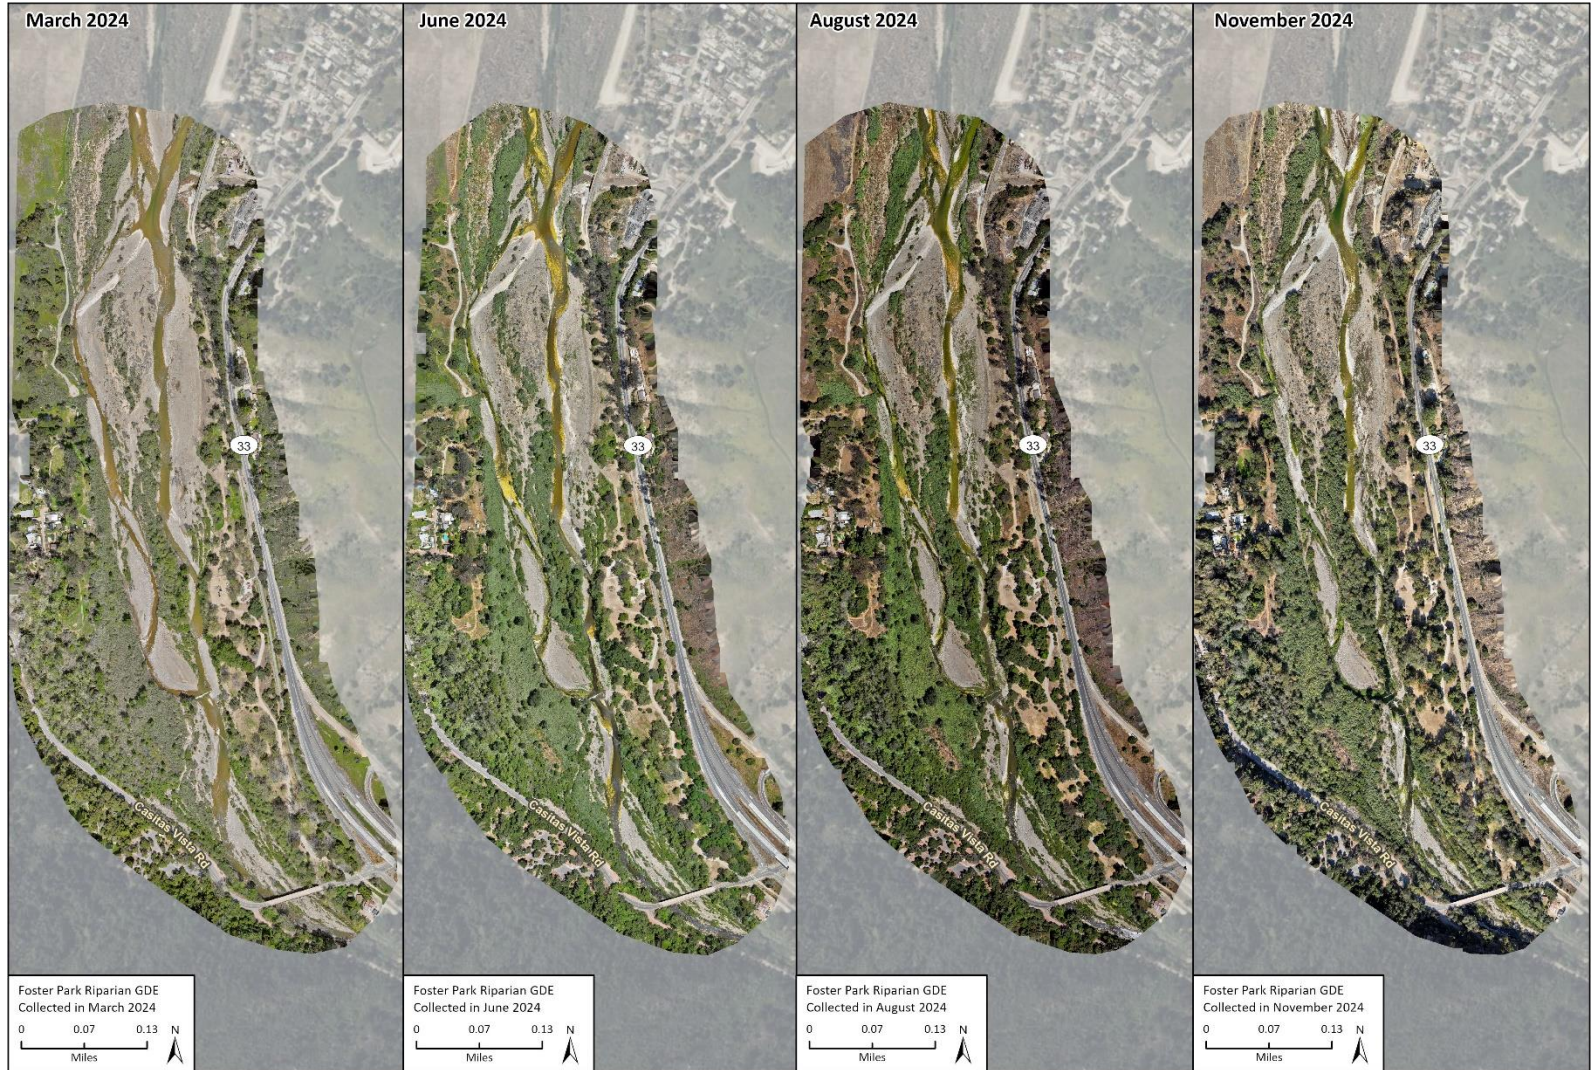
Figure 5 Drone Orthoimagery of the Foster Park Riparian GDE Unit, Water Year 2024
