February 2, 2025
Project No: 20-10008

**Subject: Aquatic Groundwater Dependent Ecosystems Annual Data Deliverable and Three-Year Monitoring Report for Water Years 2022-2025
Upper Ventura River Groundwater Agency, Ventura County, California**

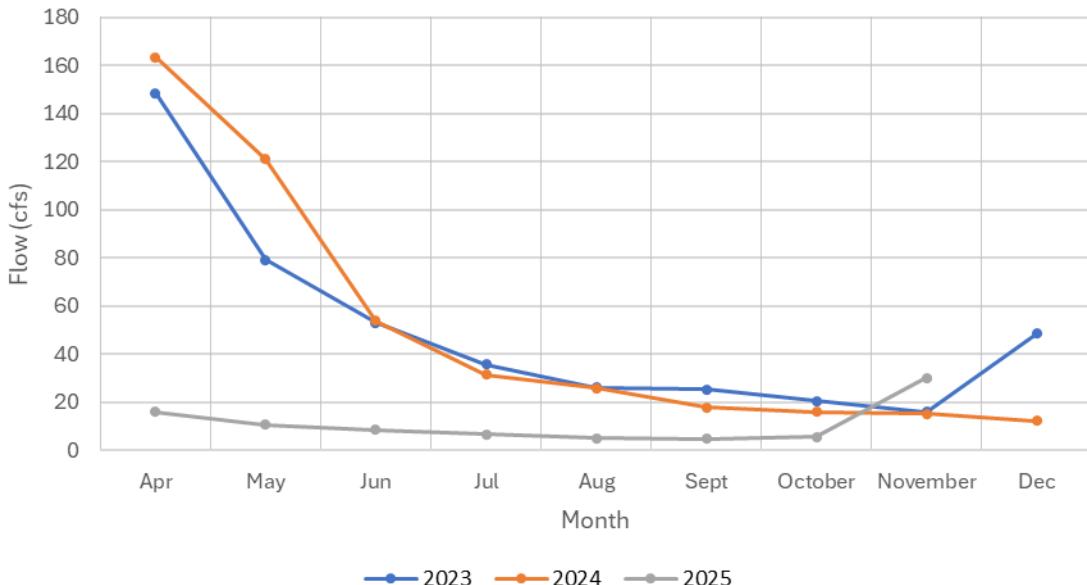
Figure 24 3-Year Instantaneous Flow Measurements at Upstream Confluence

**Figure 25 3-Year Instantaneous Flow Measurements at Downstream Confluence**

Figure 26 3-Year Instantaneous Flow Measurements at Upstream Foster Park

**Figure 27 3-Year Average Monthly Flow at USGS Staff Gage 11118500**

WYs 2023 and 2024 demonstrated sustained above-average precipitation and discharge conditions whereas WY 2025 was characterized by below-average conditions (Table 4; Figure 24 through Figure 27). However, it is noted that average daily discharge is a misleading indicator because it is strongly influenced by peak flow rates, which have little bearing on matters relevant to the GSP. Thus, the median daily discharge is a more relevant indicator for comparisons across years. During WY 2025 the median daily discharge was almost double that of the 2000-2025 period, indicating that discharge was higher than a typical year. The higher than typical median flow despite low rainfall during WY 2025 was the result of antecedent conditions, i.e., a prior wet year.
