A year in the life of Upper Ventura River Groundwater Basin

Upper Ventura River Groundwater Basin
UVRBGSA

Jordan Kear, PG, CHG
08 March 2018

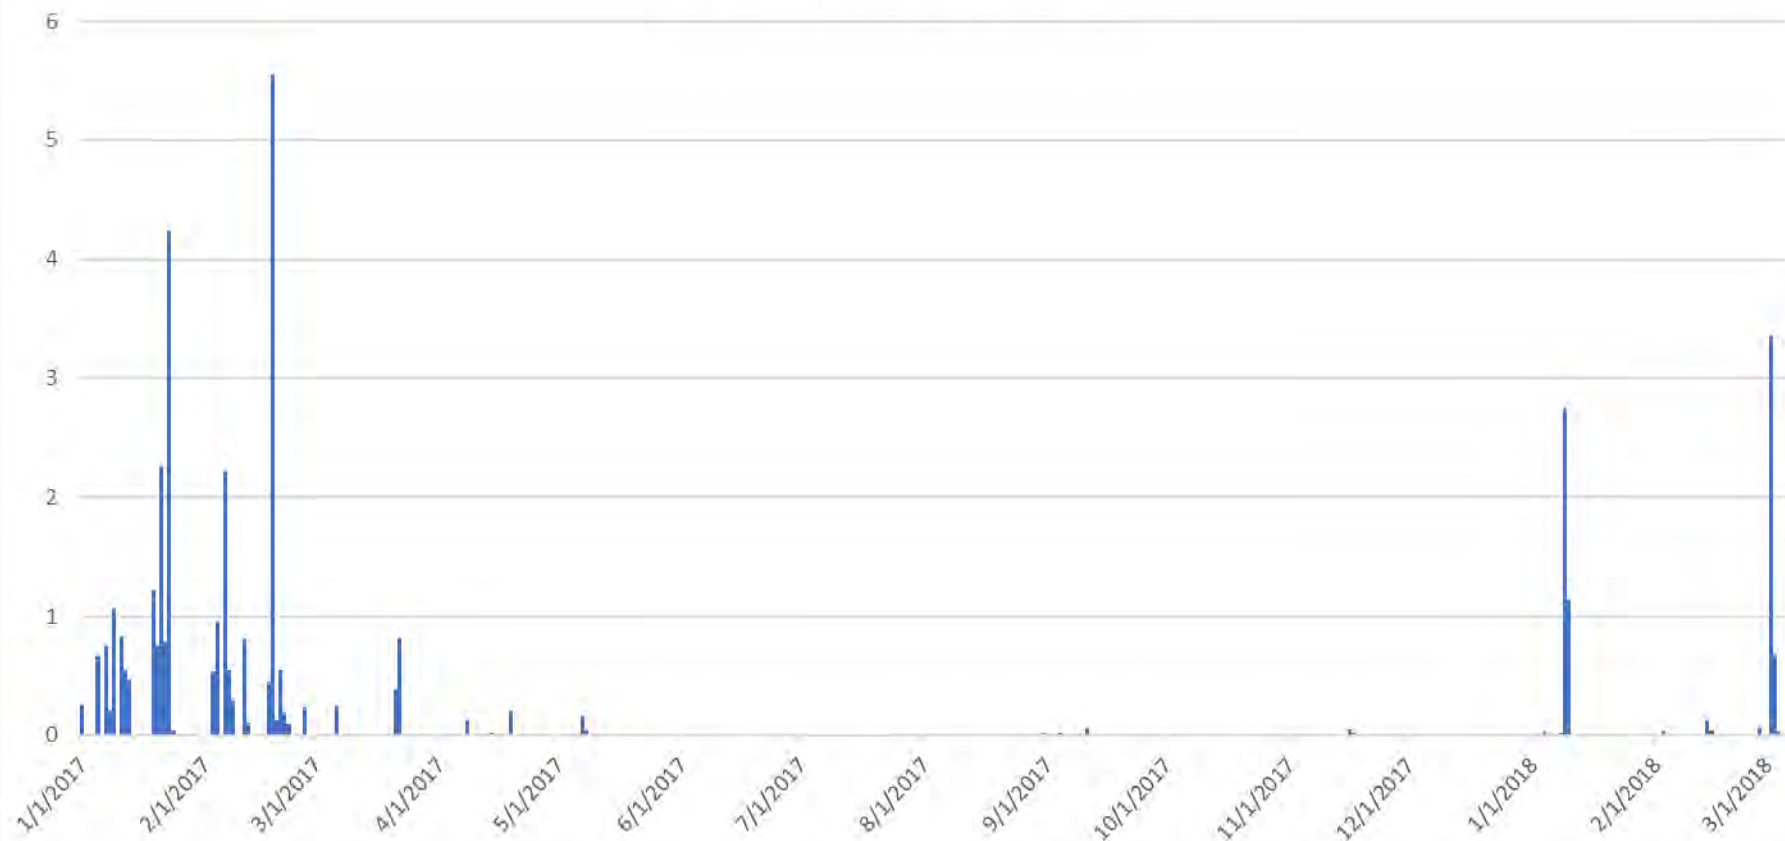
Daily Precipitation at Matilija Dam

Rain Gauge Location: 34.4480 N 119.2300 W

Rain Gauge Elevation: 745 ft (227 m) above mean sea level

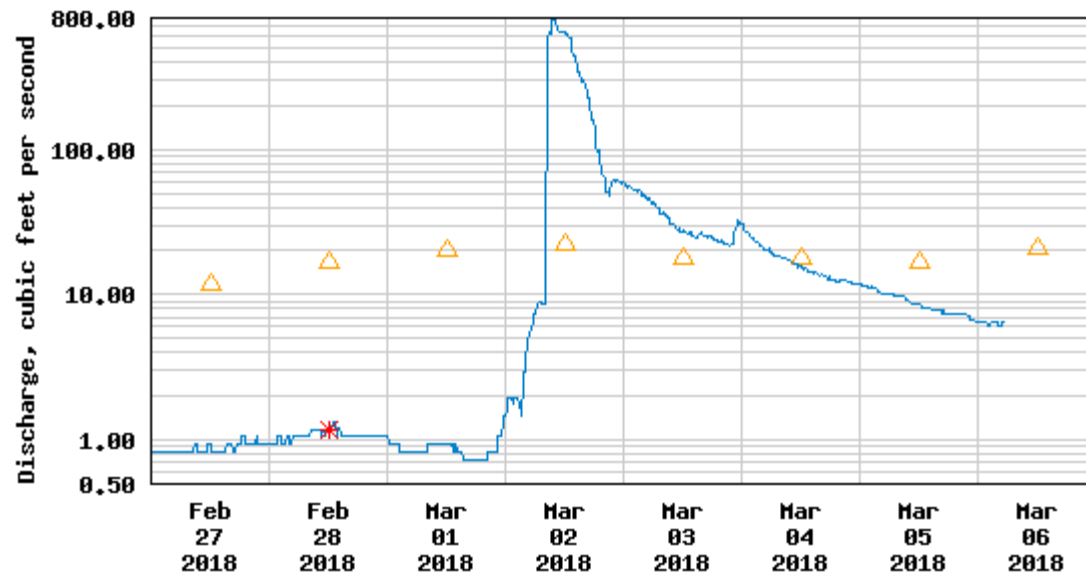
USGS 11118500 VENTURA R NR VENTURA

△ Median daily statistic (58 years) * Measured discharge
— Discharge

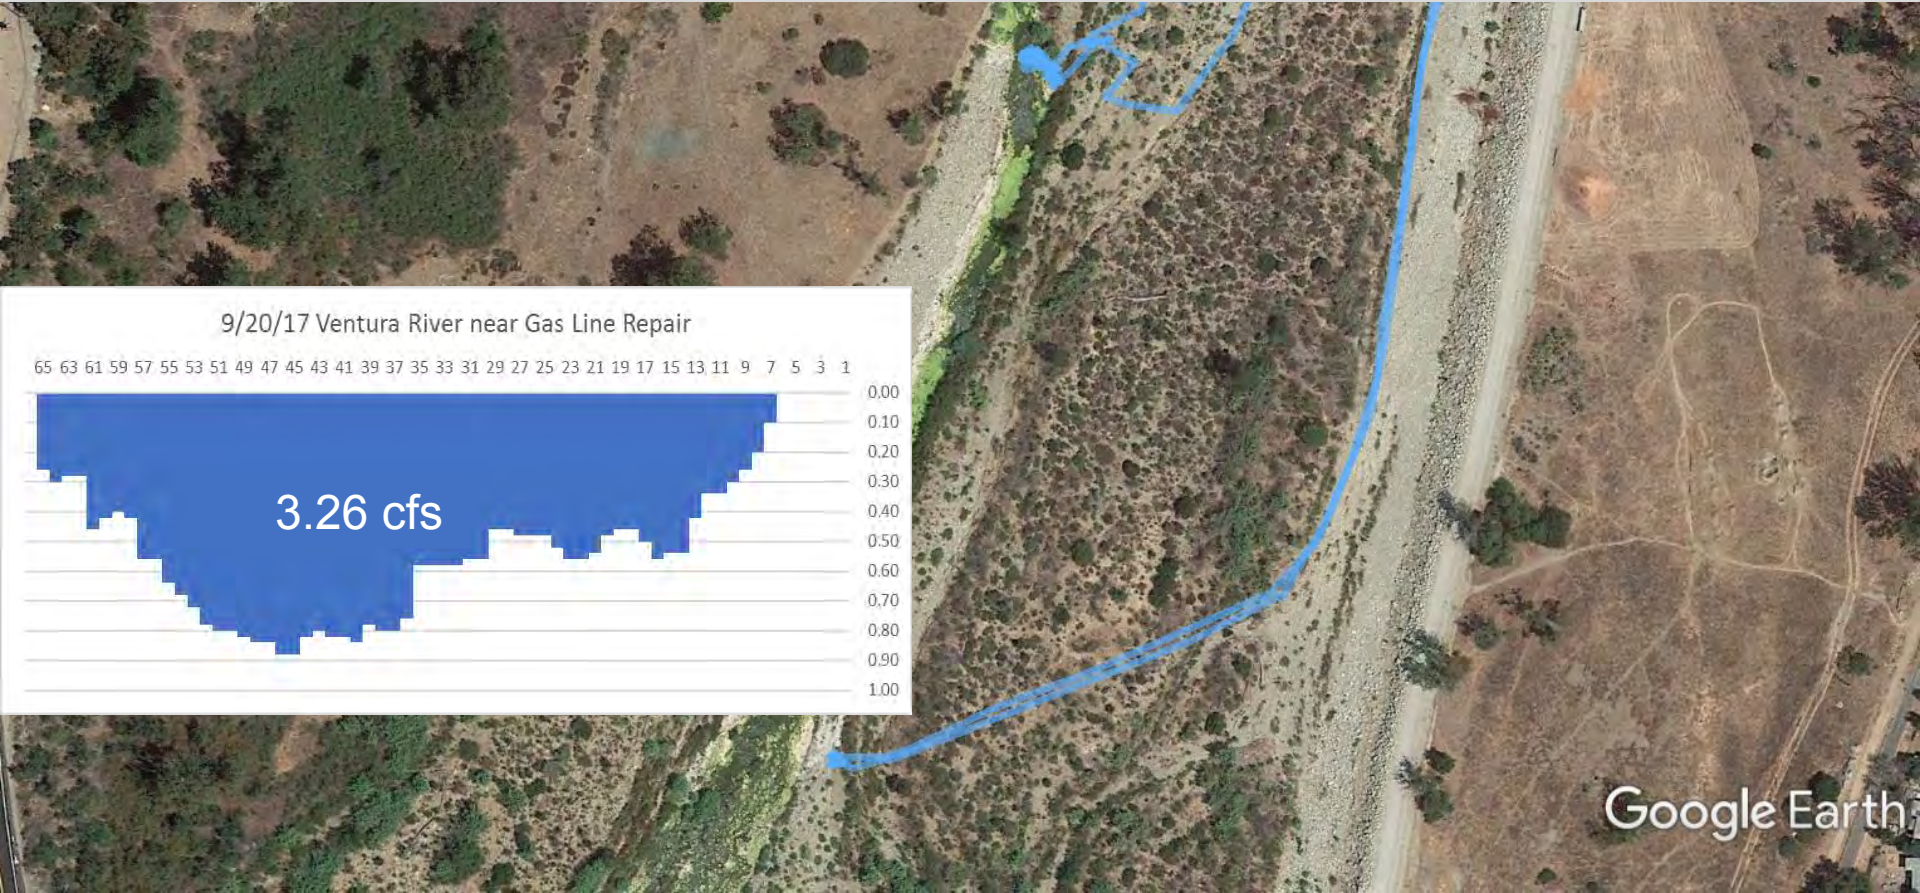
A satellite map of the Ojai area in Southern California. A yellow line runs vertically through the center-right of the image. Several locations are marked with yellow dots and labeled: MOWD 8, Gramkow 9B1, VRWD MW2, 1000 Burnham, 873 Santa Ana, and Casitas Springs. Other labels on the map include Ojai, Mira Monte, Burnham Road, Oak View, Main Island, Casitas Springs Mobile Home Park, and Mussel Shoals. The terrain is rugged and hilly, with some green vegetation and brownish soil. A blue line outlines a body of water in the lower-left quadrant.

MOWD 8
Gramkow 9B1
VRWD MW2
1000 Burnham
873 Santa Ana
Casitas Springs

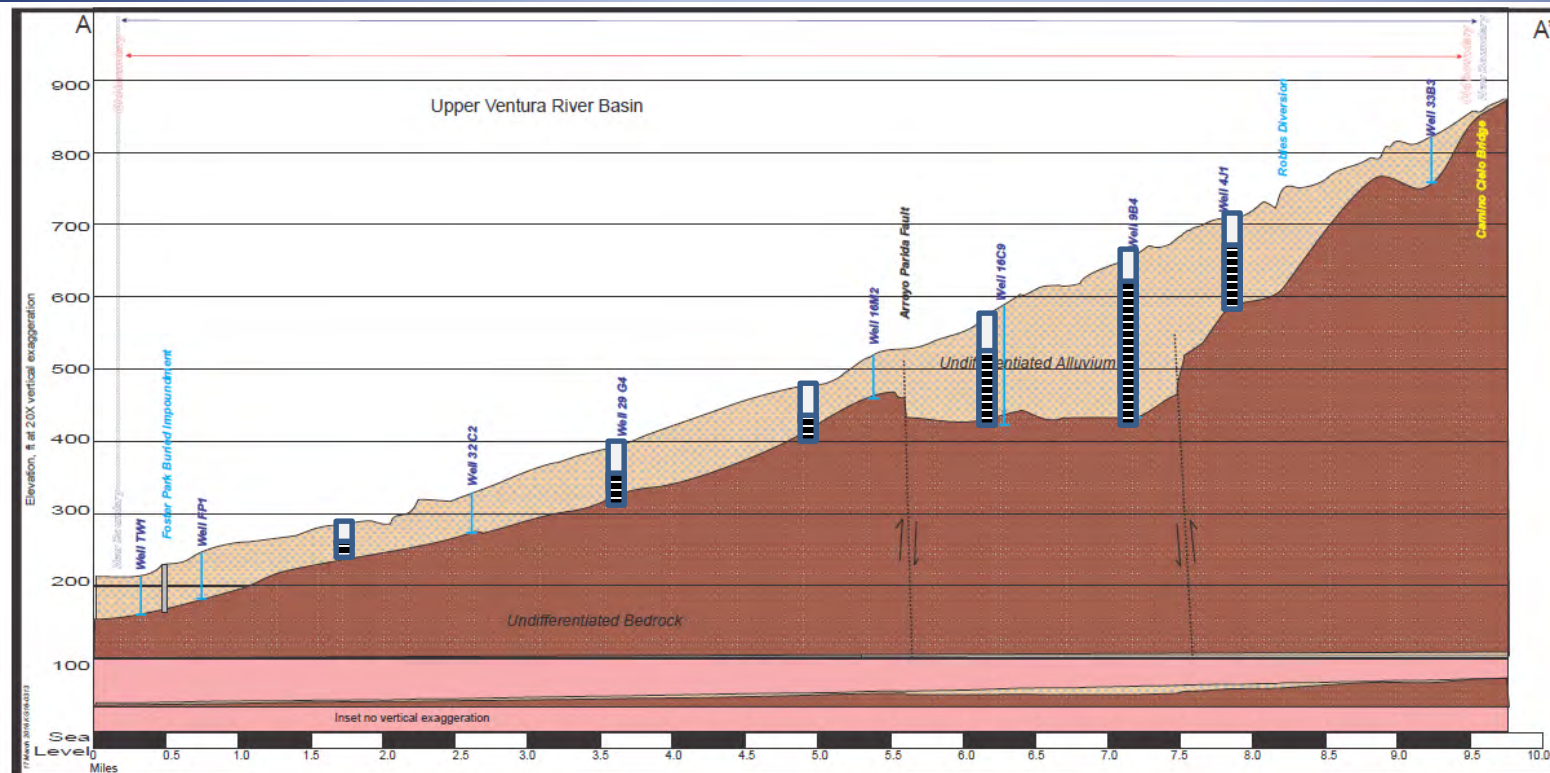
Figure 4
Central Cross Section
Ventura River Profile
View looking west

Upper Ventura River Basin

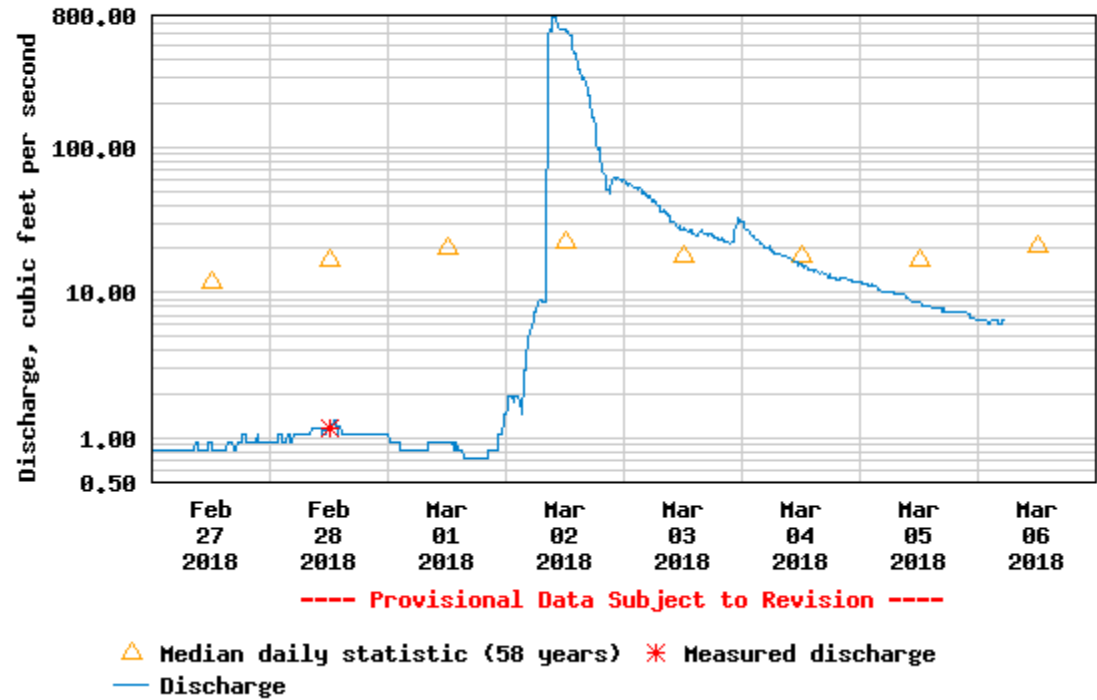
USGS 11118500 VENTURA R NR VENTURA

6.2 cfs
28 February 2018

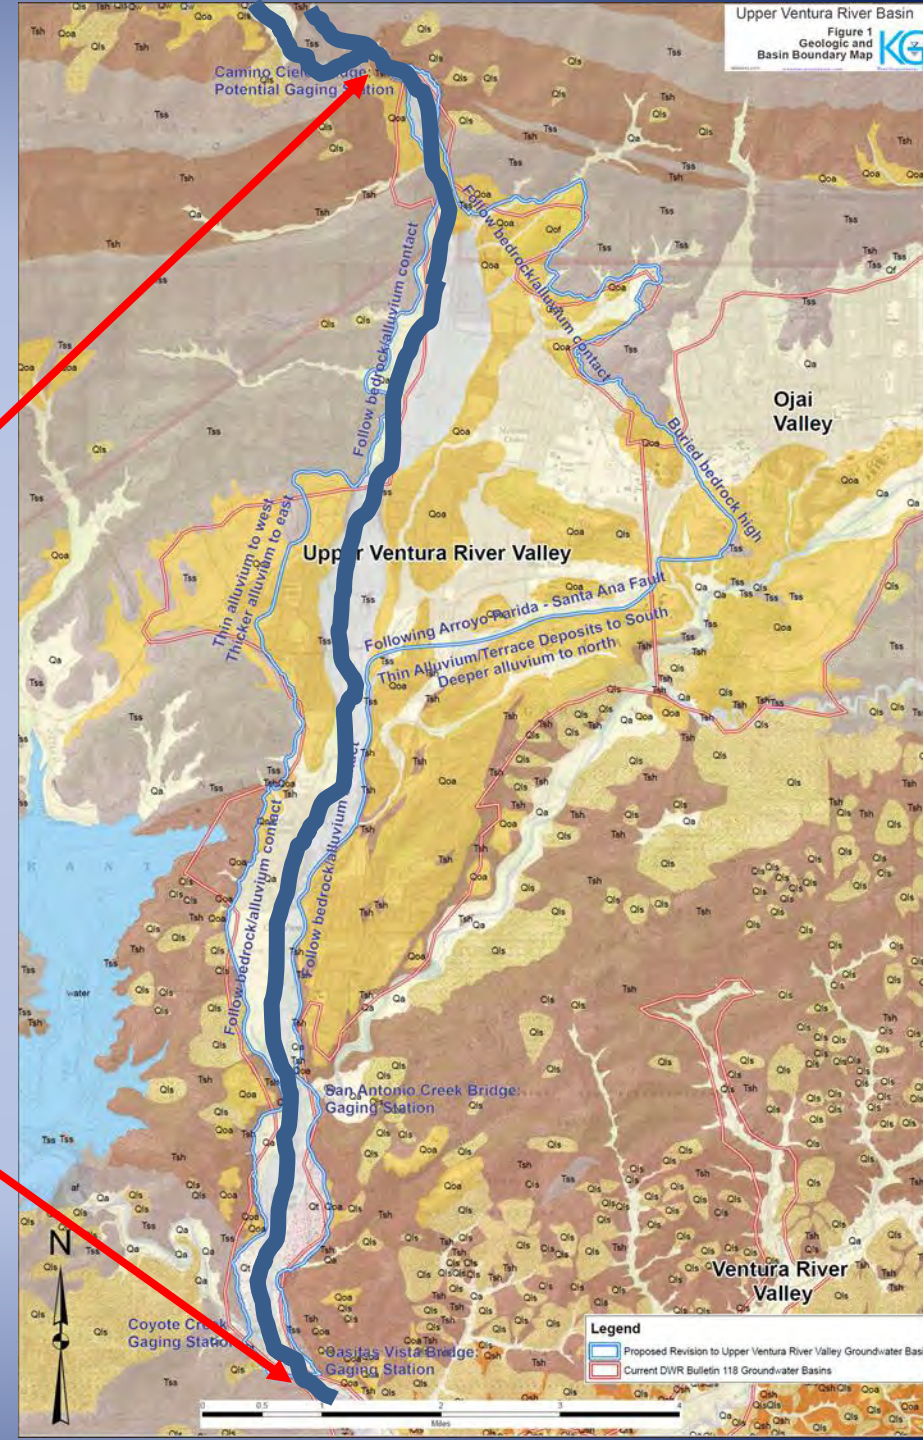
INFILTRATION FLUX

6.2 cfs at Camino Cielo Bridge

1.2cfs at Highway 150 bridge

=5 cfs/5 mi => 1 cfs / mile

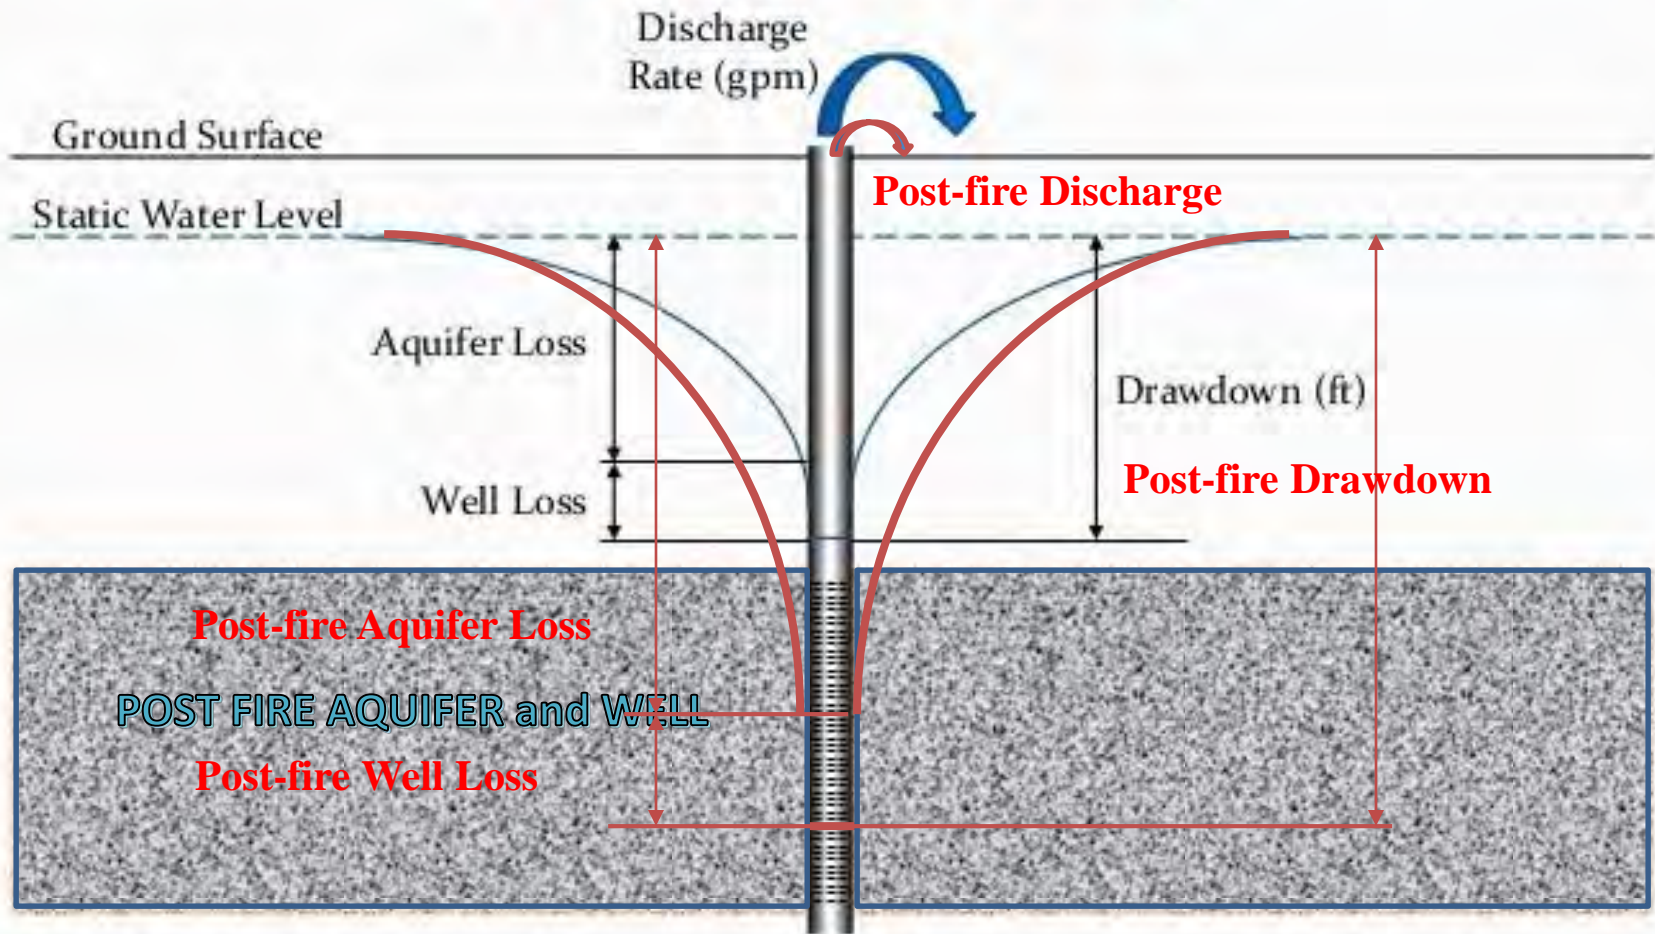
Well Efficiency

$$\text{Well Efficiency (\%)} = \text{Aquifer Loss} / \text{Total Drawdown}$$
