January 2, 2024 Project No: 20-10008

#### Subject: Aquatic Groundwater Dependent Ecosystems Monitoring for Water Year 2023 Upper Ventura River Groundwater Agency, Ventura County, California

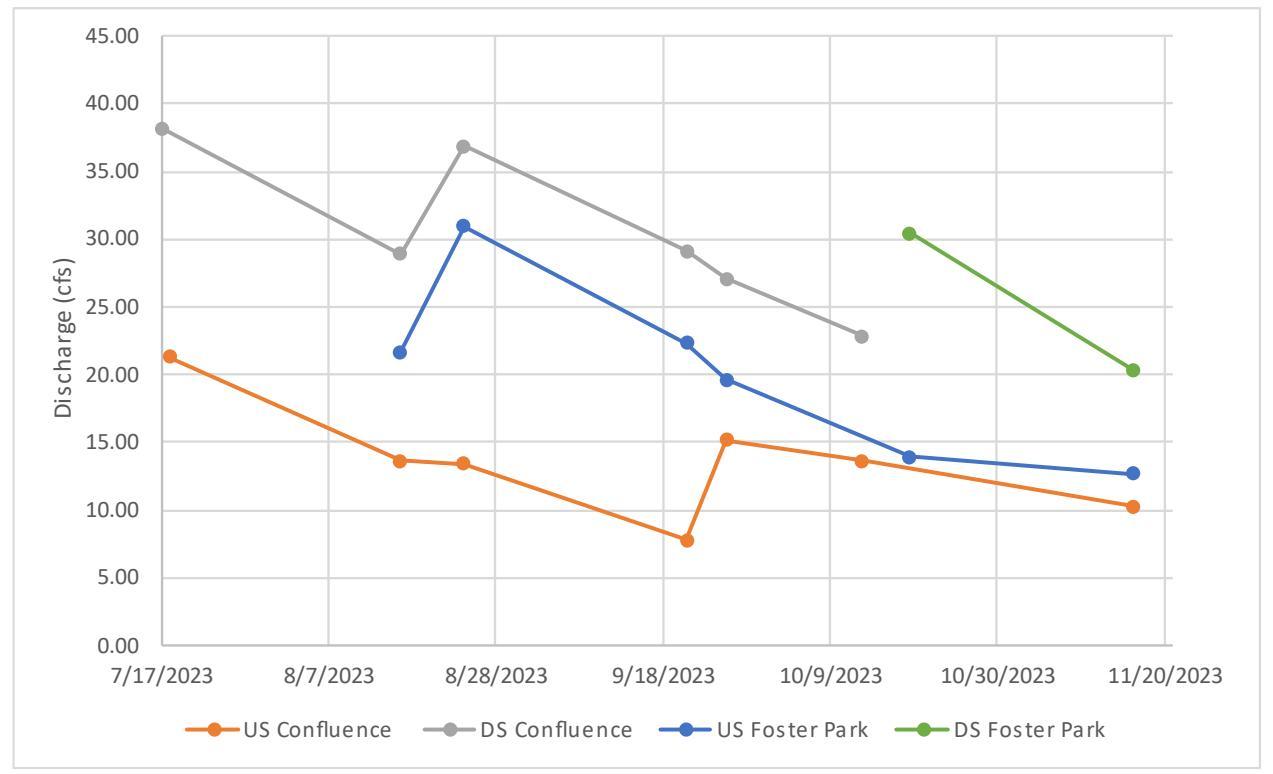
Figure 2 Instantaneous Discharge Measurements

Instantaneous discharge measurements collected to support rating curve development were measured for a limited range of flow conditions observed during the 2023 Water Year monitoring period (Figure 2). This prevents the development of robust empirical rating curves spanning water depth ranges outside of those measured by the continuous pressure transducers. To address this, Rincon developed a stage-discharge rating curve using HydroCalc Version 3.0c software (HydroCalc), which utilizes Manning's equation to model flow rates from observed depth of water and channel dimensions (Figure 3 and Figure 4). Manning's roughness coefficients were selected based on substrate type and slope was back calculated using a normal depth calculator provided by the National Weather Service.<sup>1</sup>

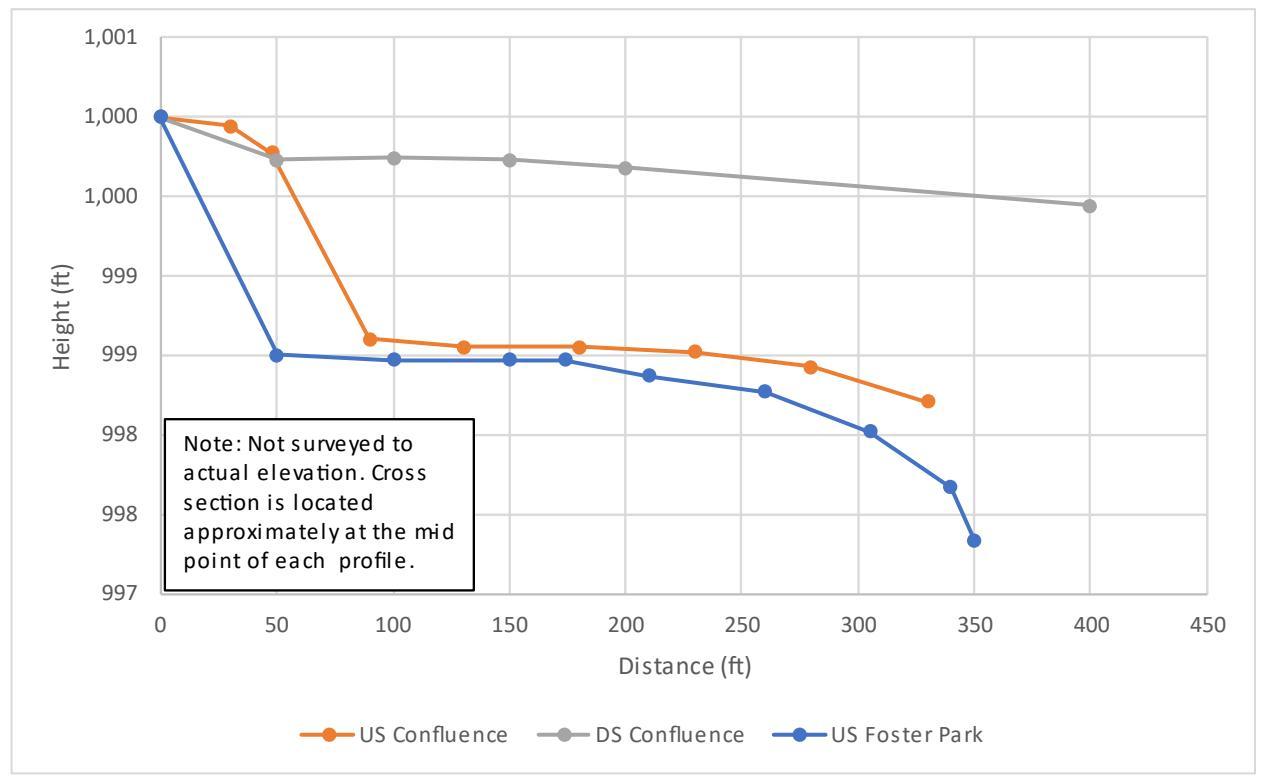
Figure 5 Upstream Confluence Rating Curve

Calibration of the rating curves involved utilizing field-derived flow measurements, and a best-fit curve was applied to the HydroCalc outputs to establish an equation for calculating discharge rates based on stream depths at the thalweg. See Figure 5, Figure 6, and Figure 7 for Upstream Confluence, Downstream Confluence, and Upstream Foster Park rating curves, respectively. While Manning's equation-derived rating curves may exhibit inaccuracies beyond the calibration data range, the pressure transducer-derived depths consistently fell within the established calibration range, resulting in reliable calculated flow rates (Figure 8, Figure 9, and Figure 10) throughout the monitoring period. The hydrograph for Downstream Foster Park developed by USGS is provided in Figure 11.

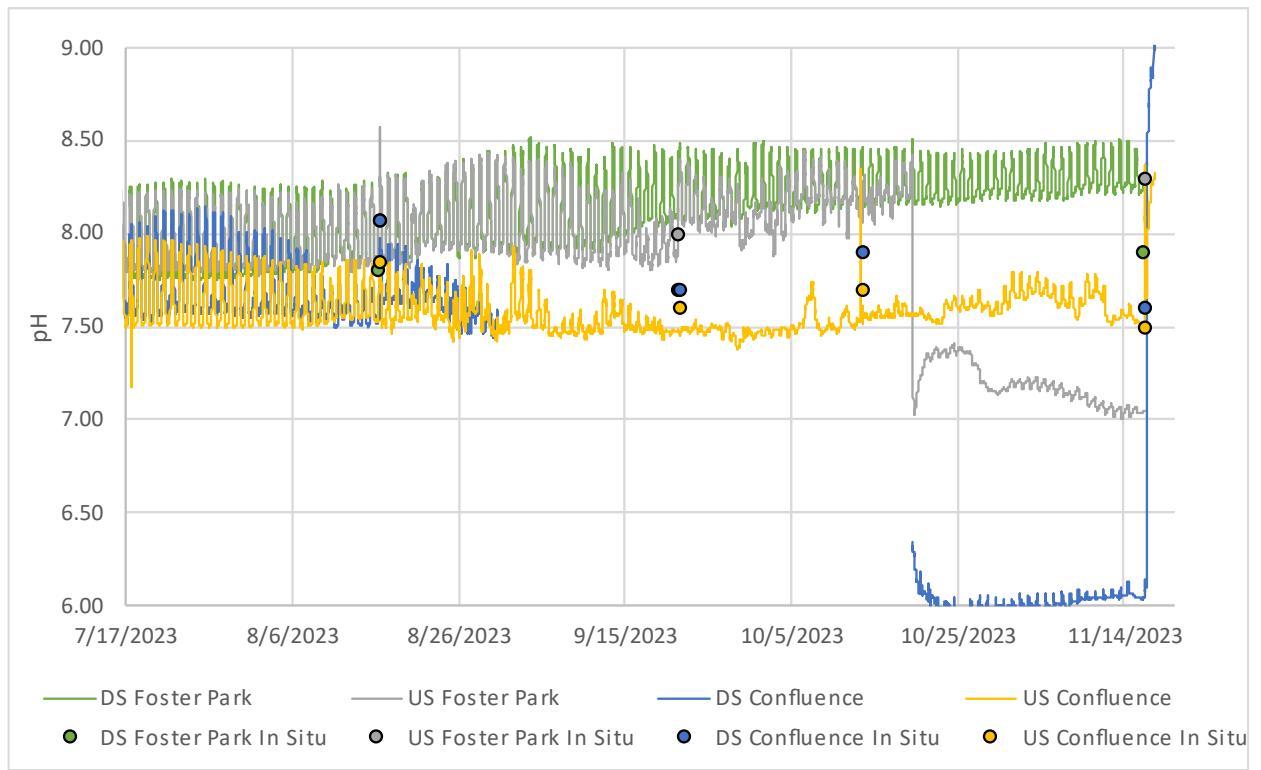
Figure 12 pH Data Logger and In Situ Measurements

See Figure 12, Figure 13, and Figure 14 for pH, dissolved oxygen, and temperature data logger and in situ measurements.

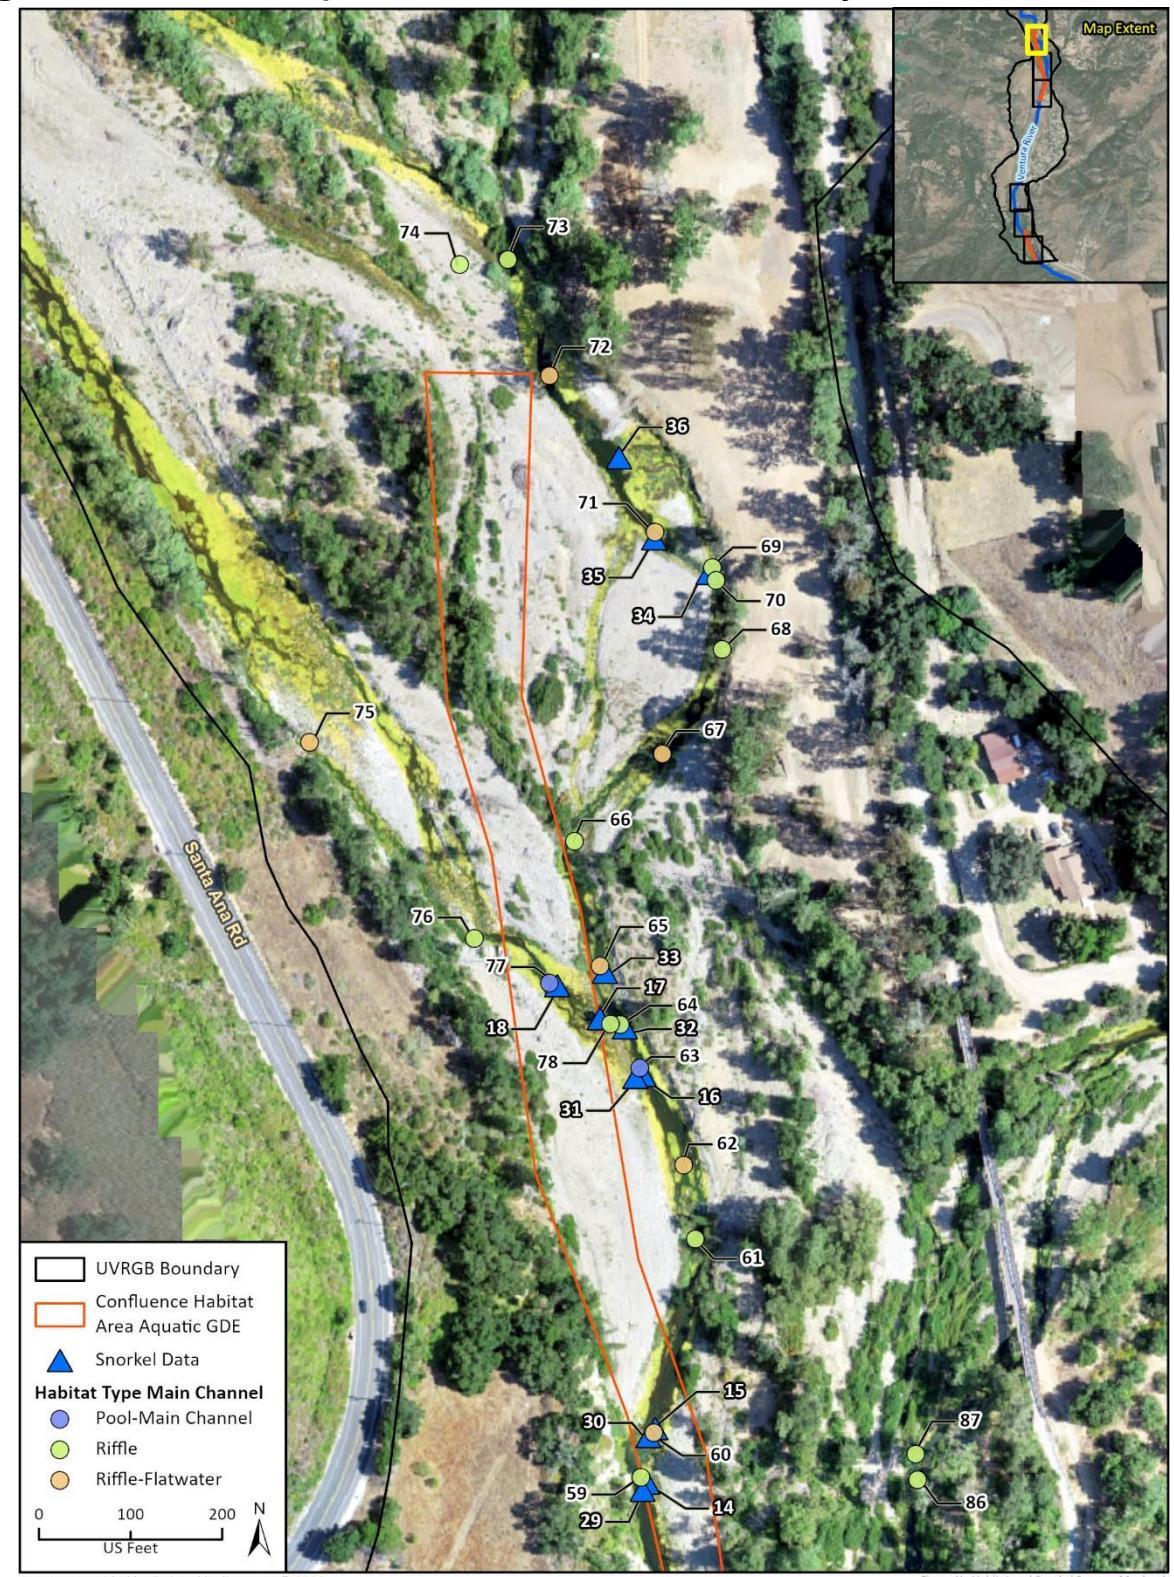
Figure 15 Confluence Aquatic GDE Habitat and Snorkel Survey Locations

Figure 15 through Figure 20 depict the mesohabitat survey locations along with snorkel survey locations for the Confluence and Foster Park Aquatic GDEs. Table 3 and Table 4 presents the habitat and snorkel survey data, respectively. No stranding or mortality occurrences were observed during the

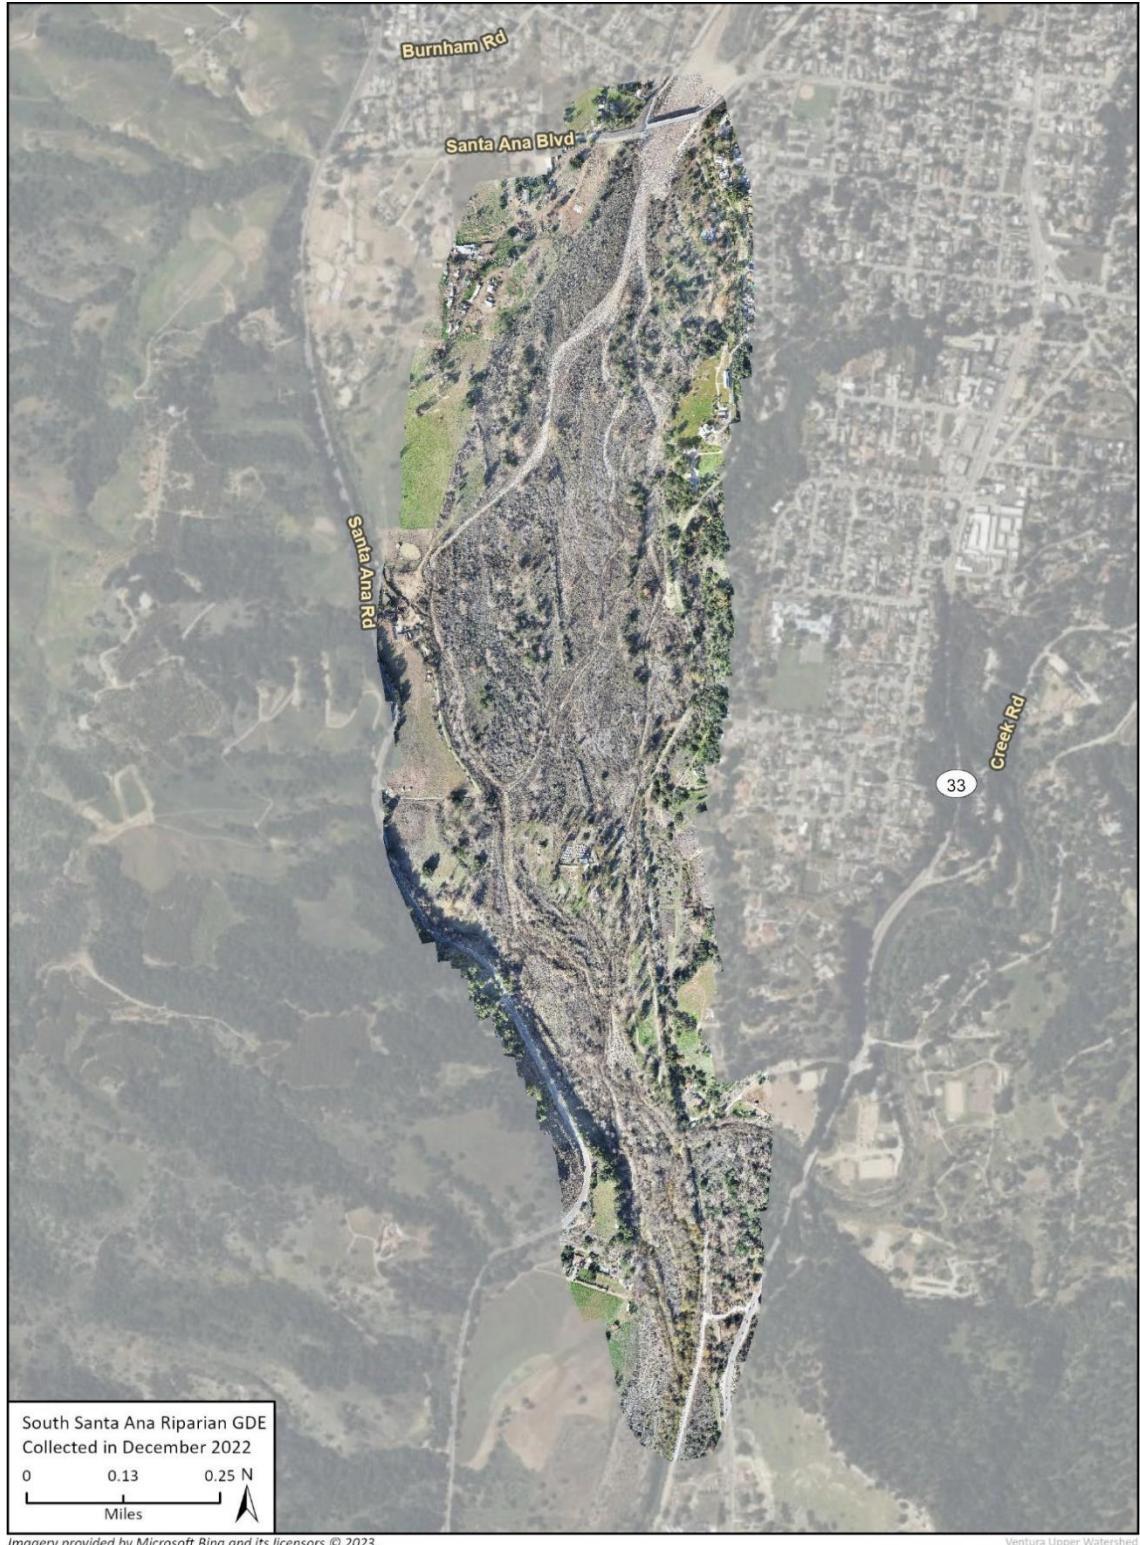
Figure 21 Drone Orthoimagery of the South Santa Ana Riparian GDE Unit, December 19, 2022

Aerial photography collected during the 2023 Water Year for the South Santa Ana and Foster Park Riparian GDE Units is provided in Figure 21 through Figure 26. The figures present orthomosaic raster images collected using a drone flown along predesignated flight paths. A Light Detection and Ranging (LiDAR) derived digital evaluation models (DEM) model for both the South Santa Ana and Foster Park Riparian GDE Units are provided in Figure 27 and Figure 28. Note that this DEM was developed under a separate work order but will be incorporated into the final monitoring assessment report.
